3010 S. Hwy 77, Suite 600
Waxahachie, Texas 75165
<http://ctctower.com>
Office: 972/923-9504
Fax: 972/923-9619

TOWER INSPECTION REPORT

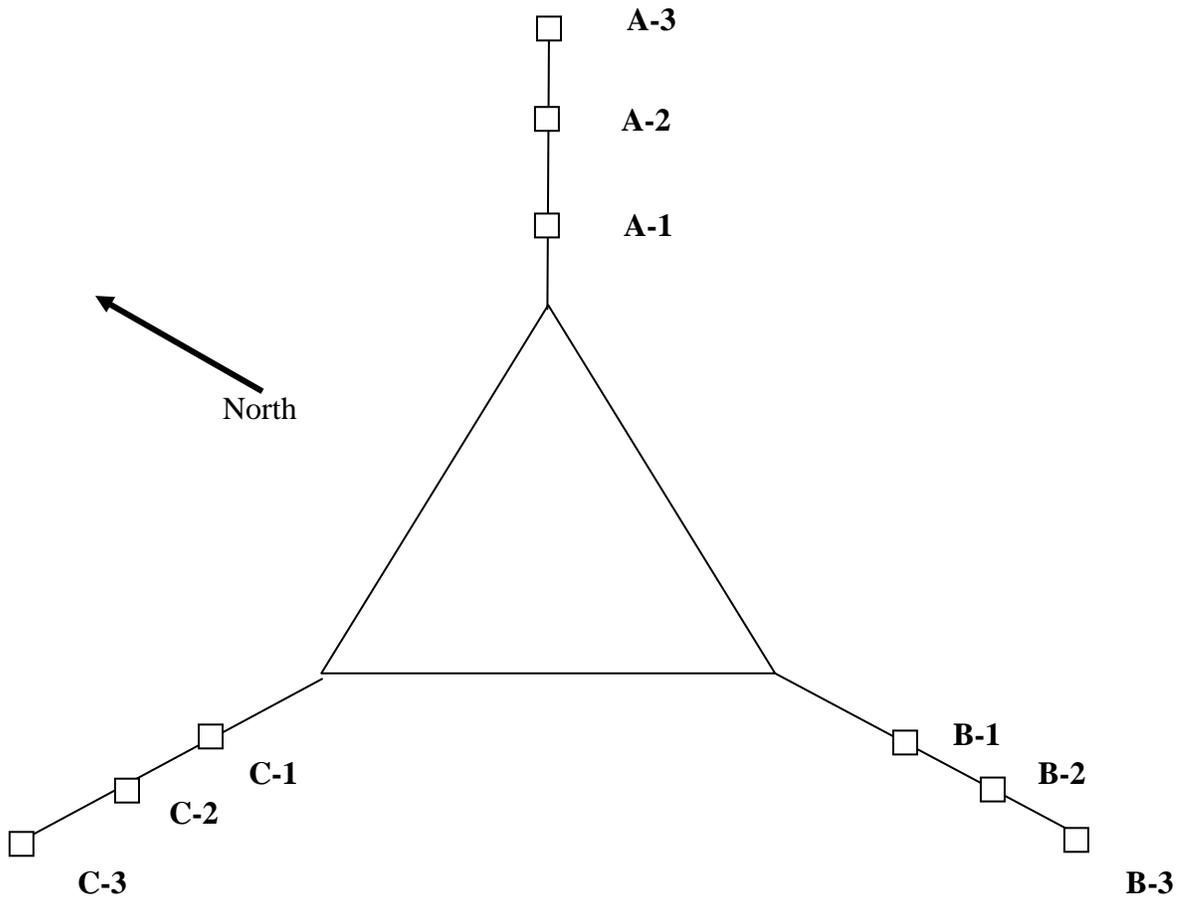
TOWER VERTICAL ALIGNMENT

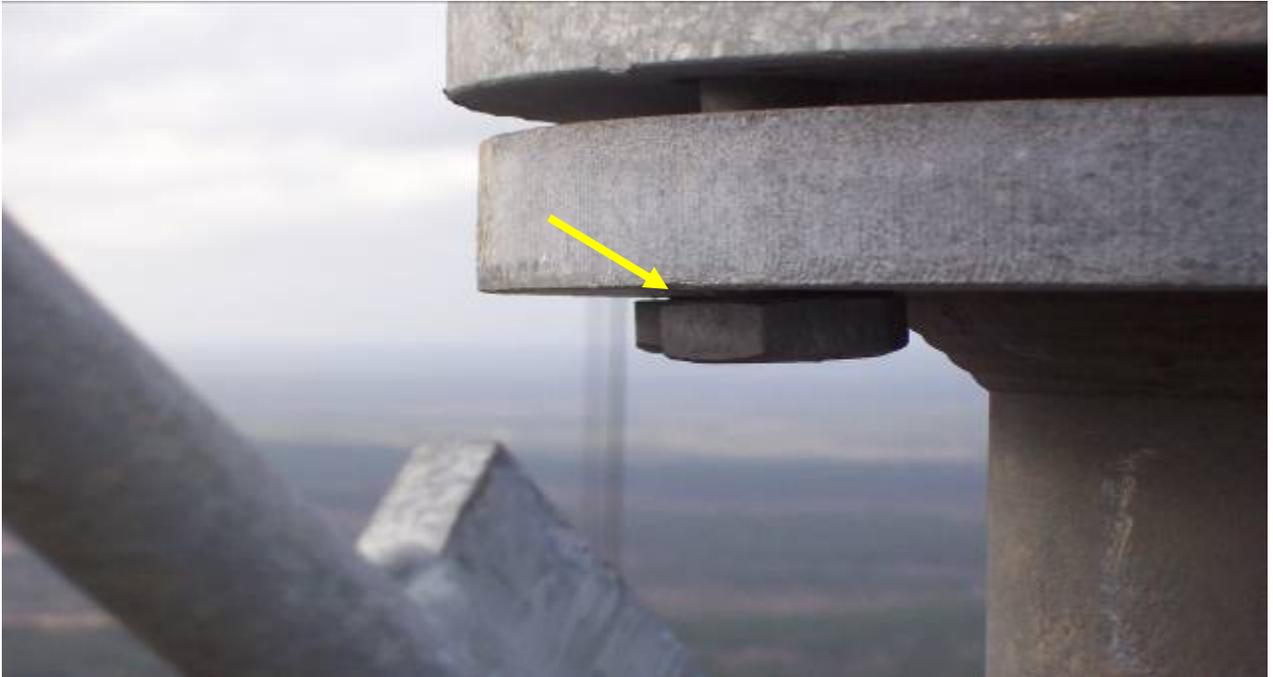
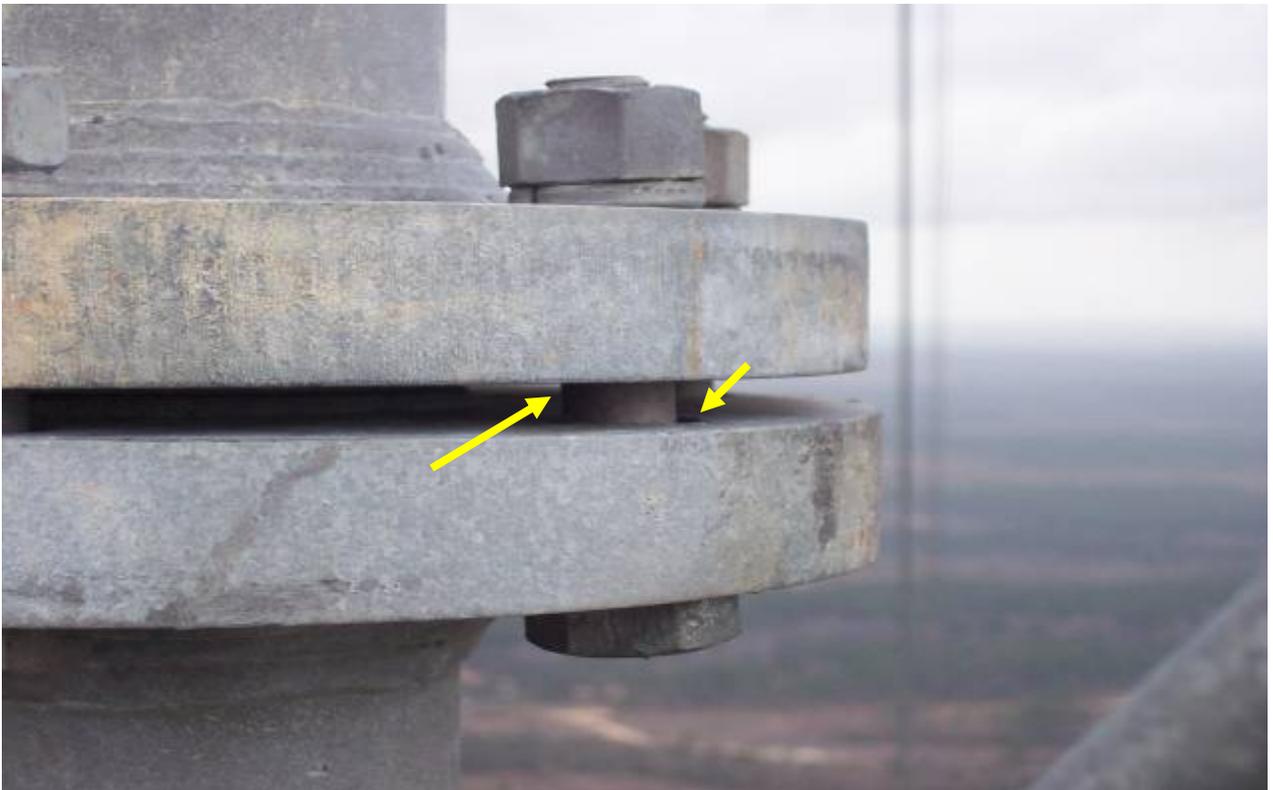
Photos show typical leg splice bolts that are misaligned due to over sized holes.

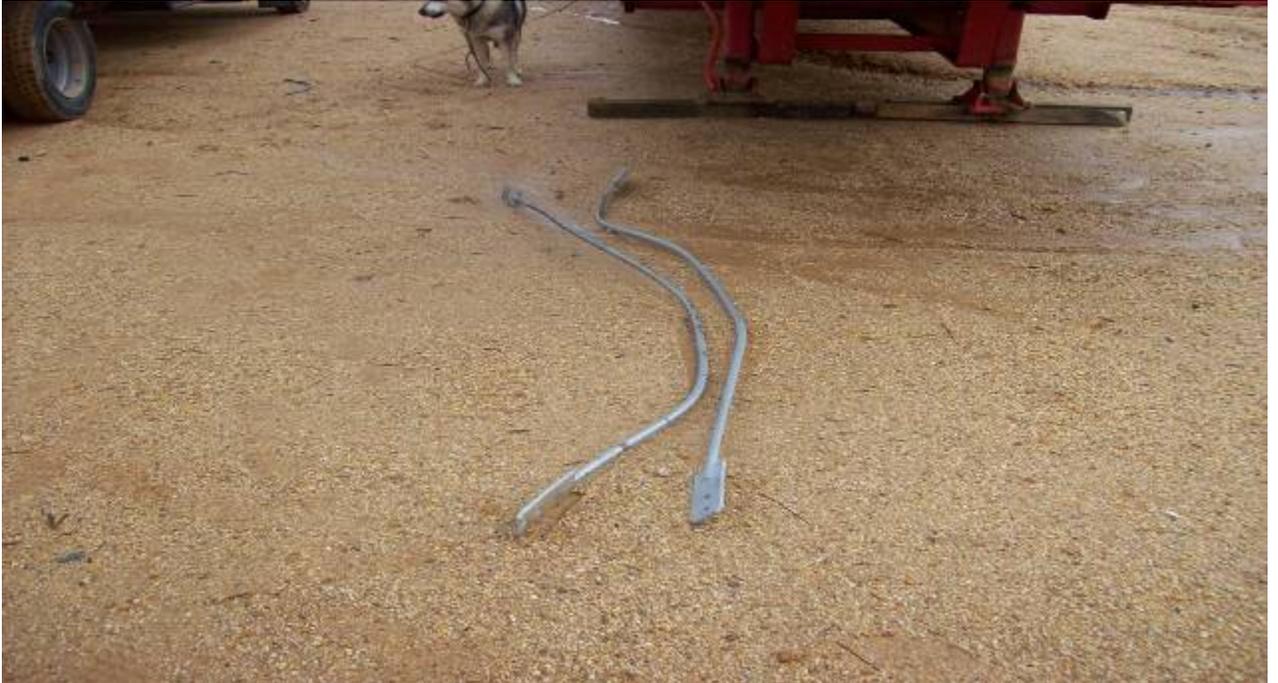
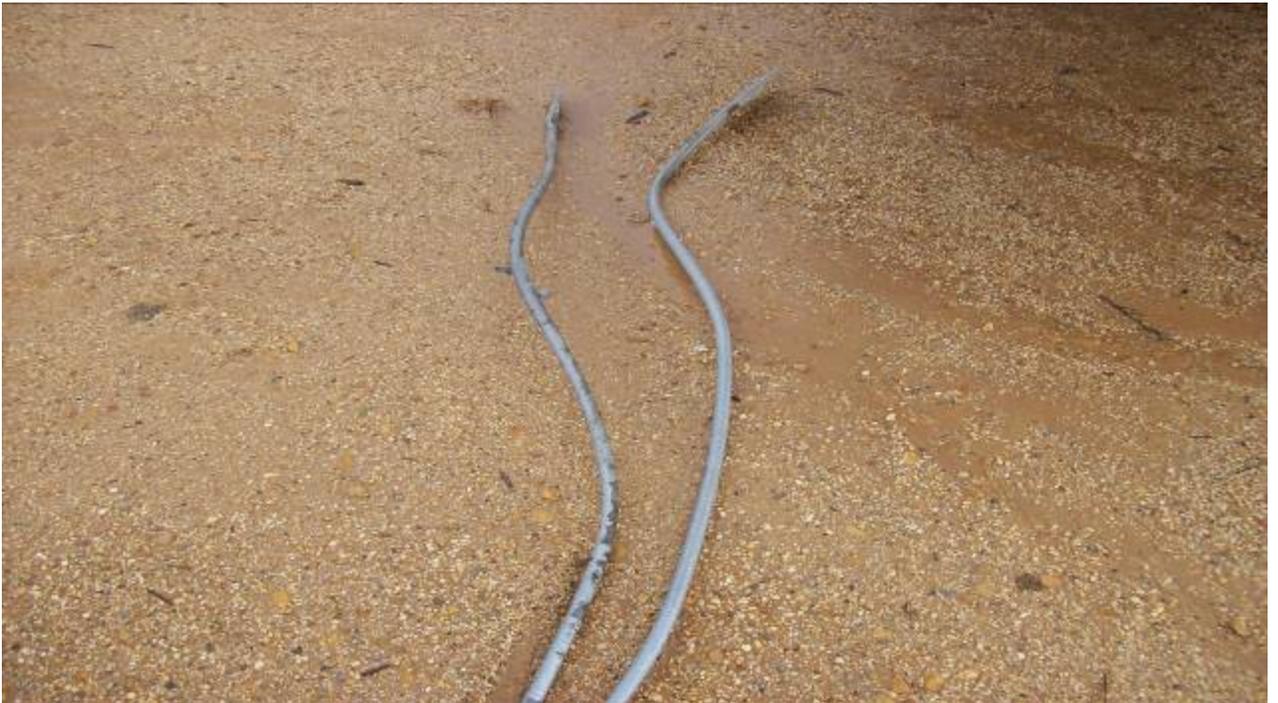
Photos show some of the damaged diagonal members that were removed from the tower after the gin pole was dropped.

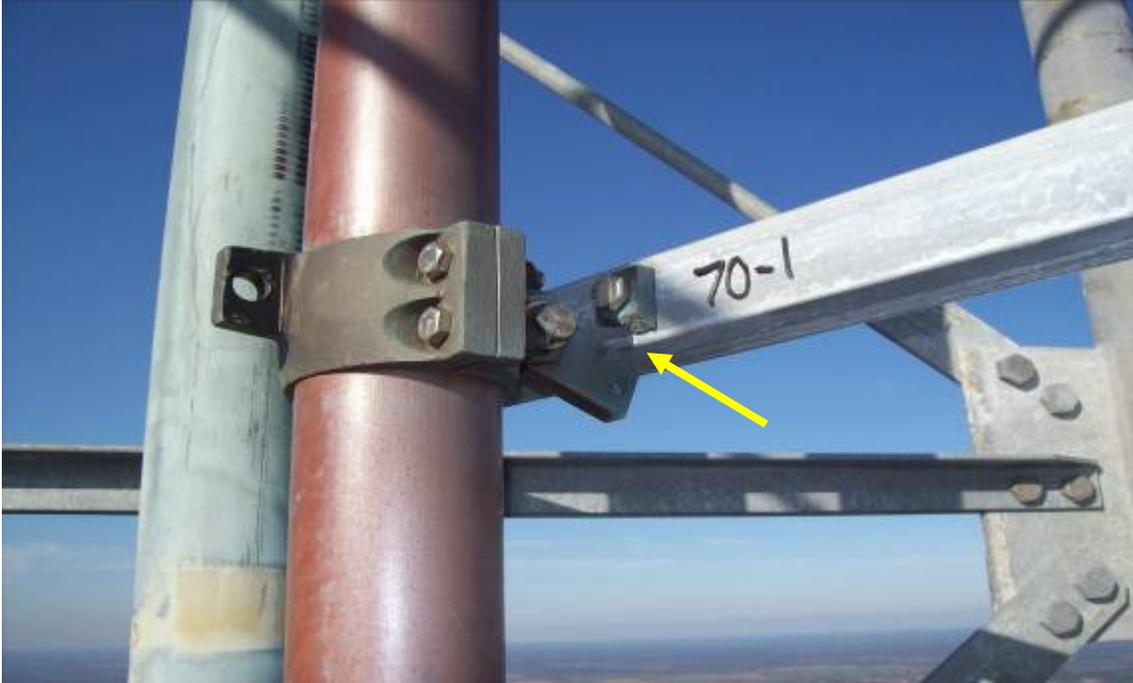
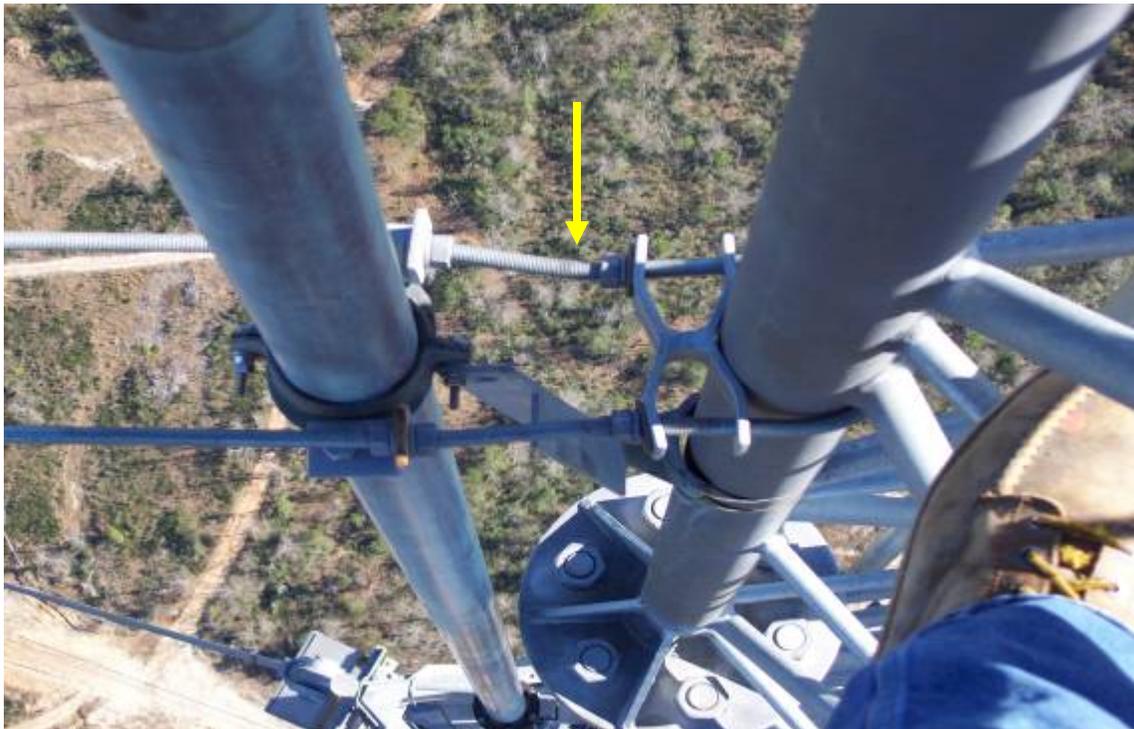
Photos show the broken fixed hanger, improperly installed and improper/damaged stand-off mounting hardware securing the 3-1/8" rigid transmission line for the top FM antenna.

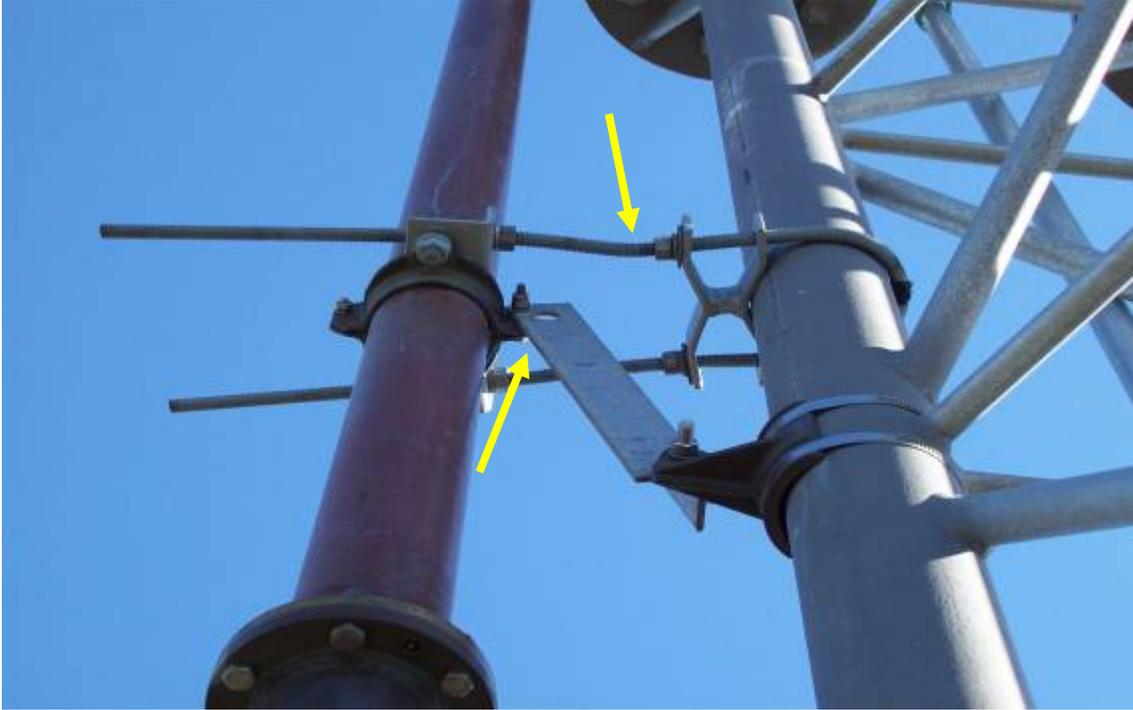
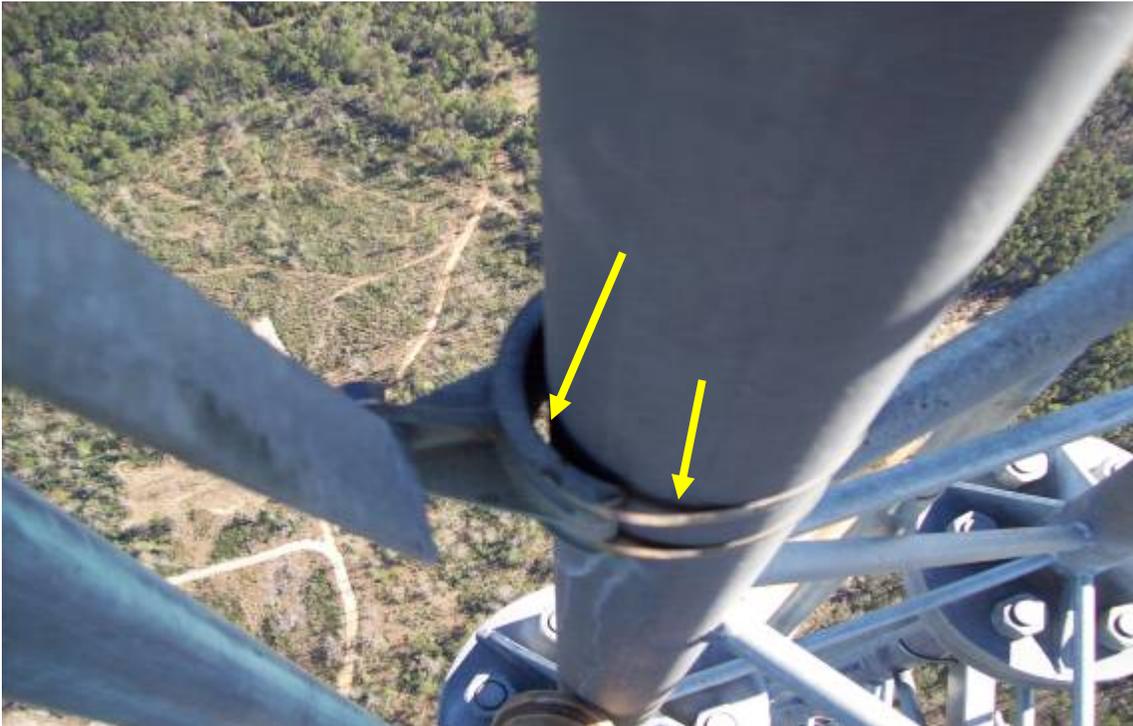
Photos show the improper/damaged stand-off mounting hardware securing the 3-1/8" rigid coax main feed line for the top FM antenna.

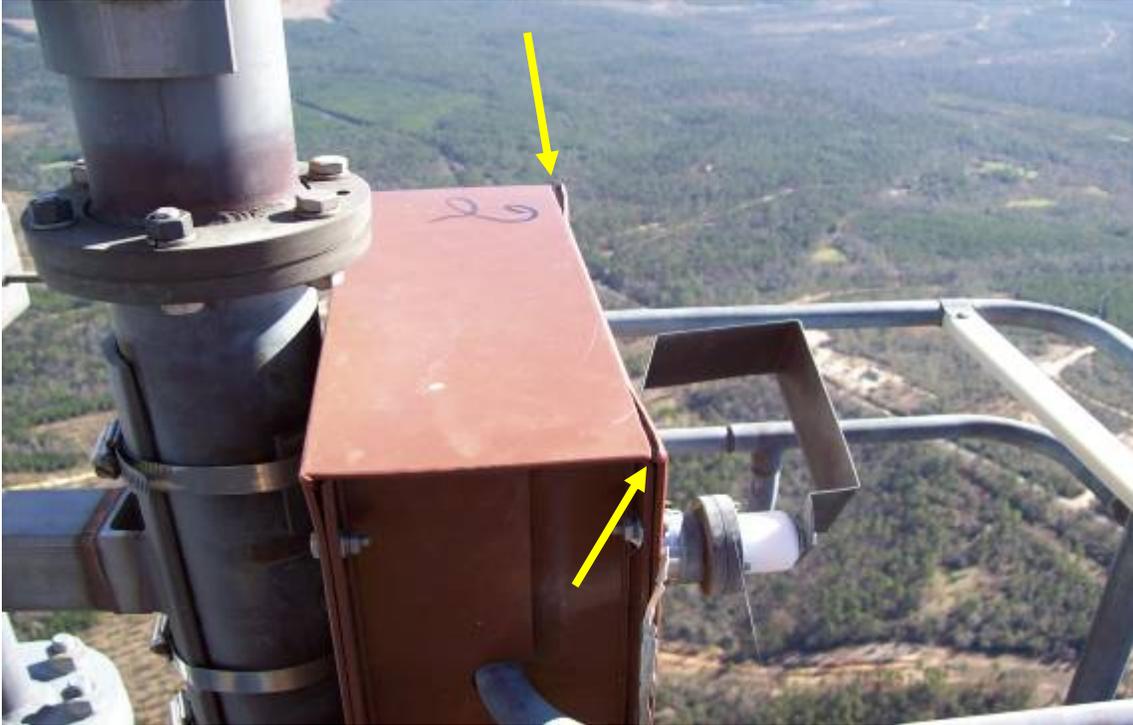
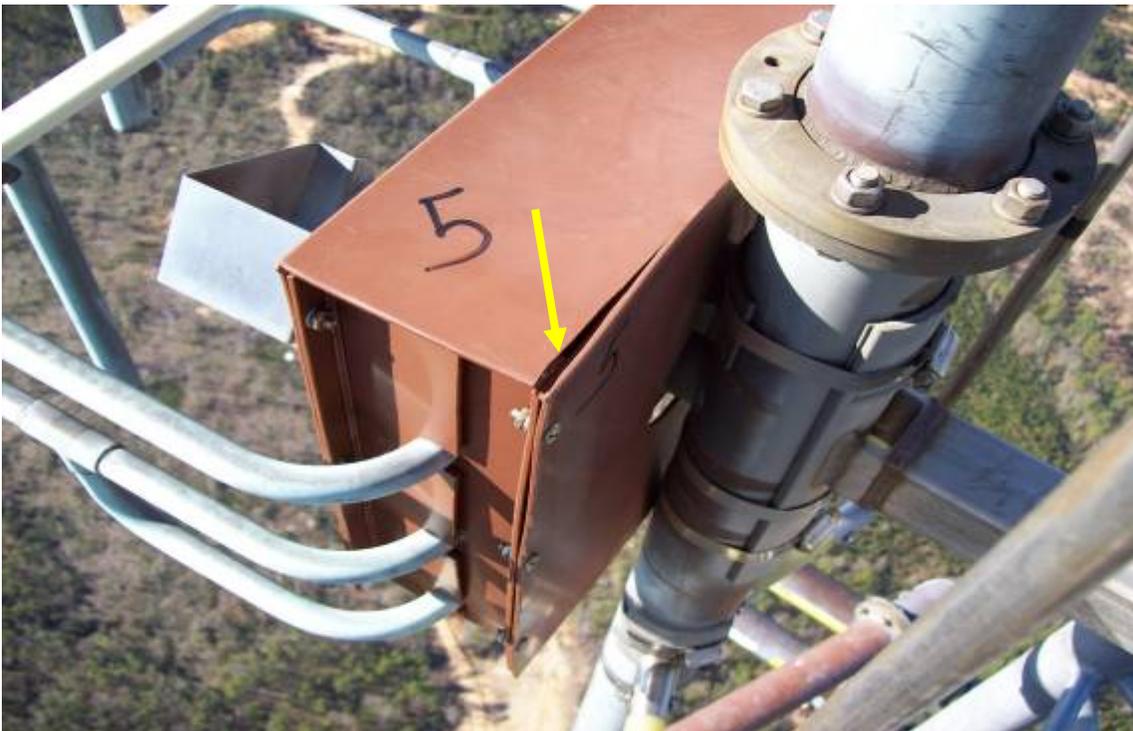
Photos show typical damaged element boxes on the top FM antenna bays.

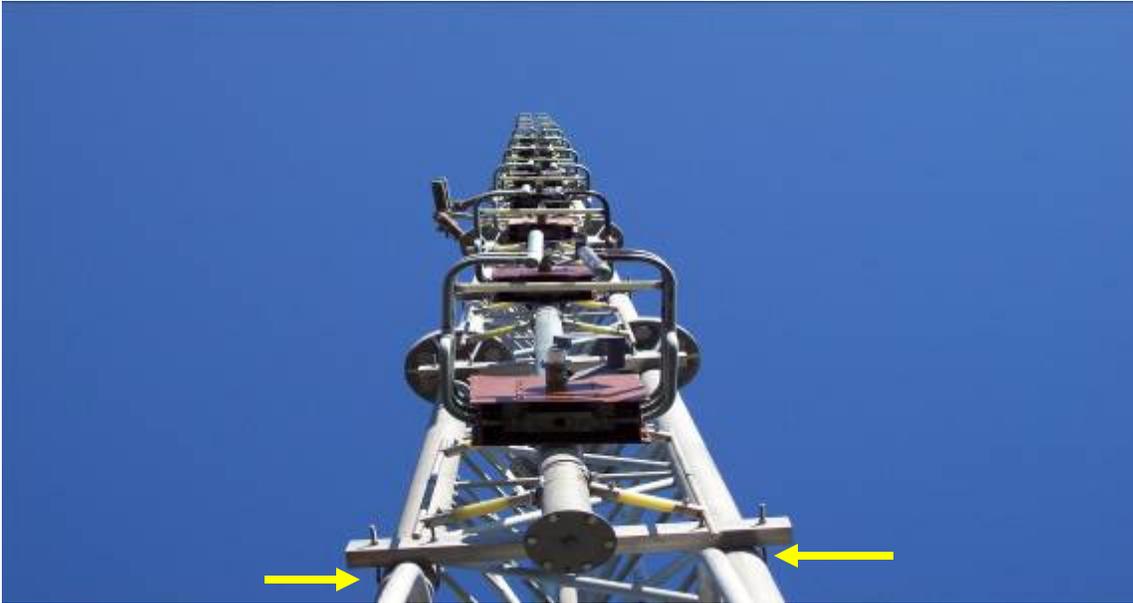
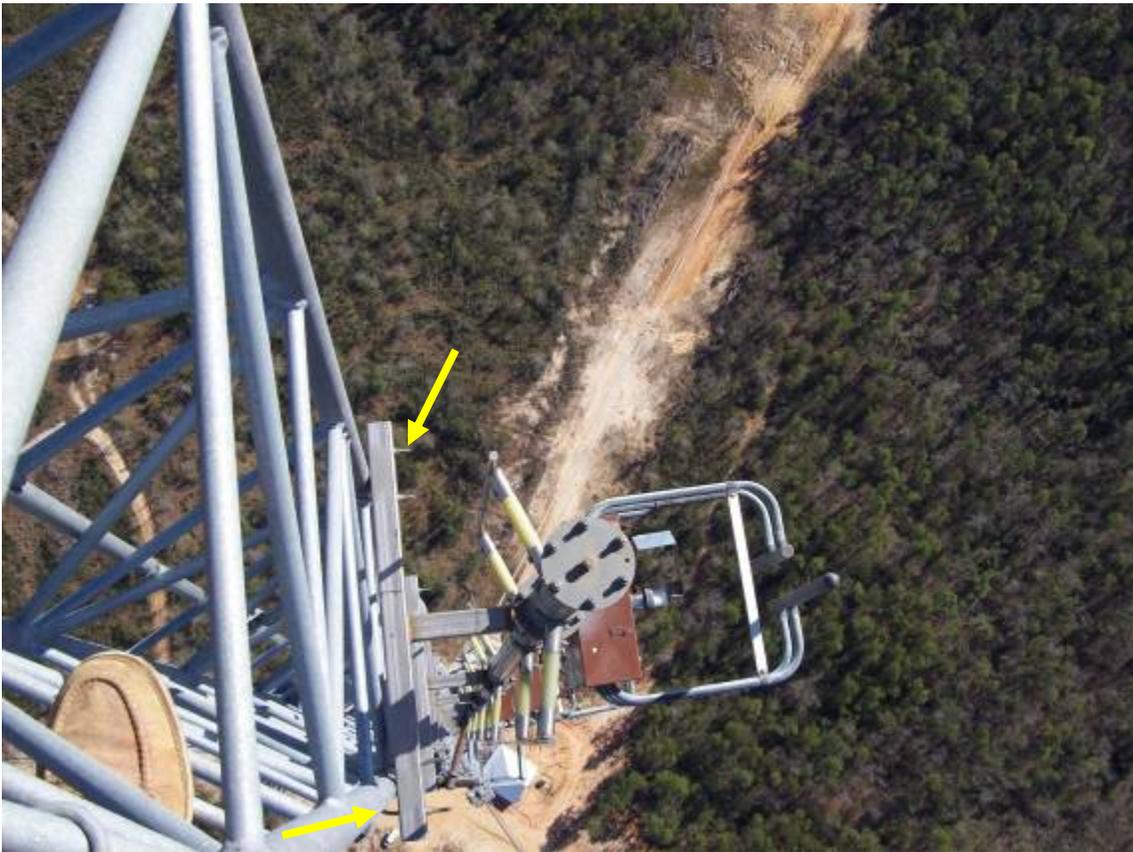
Photos show the typical oversized u-bolts used for mounting the top FM antenna.

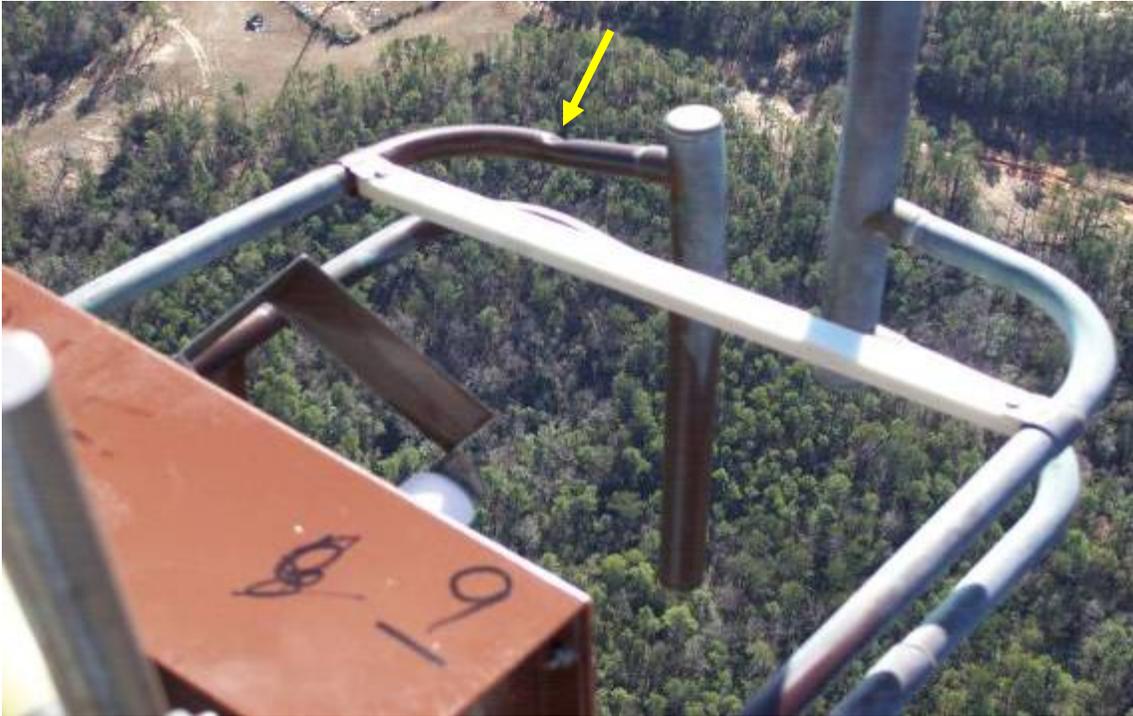
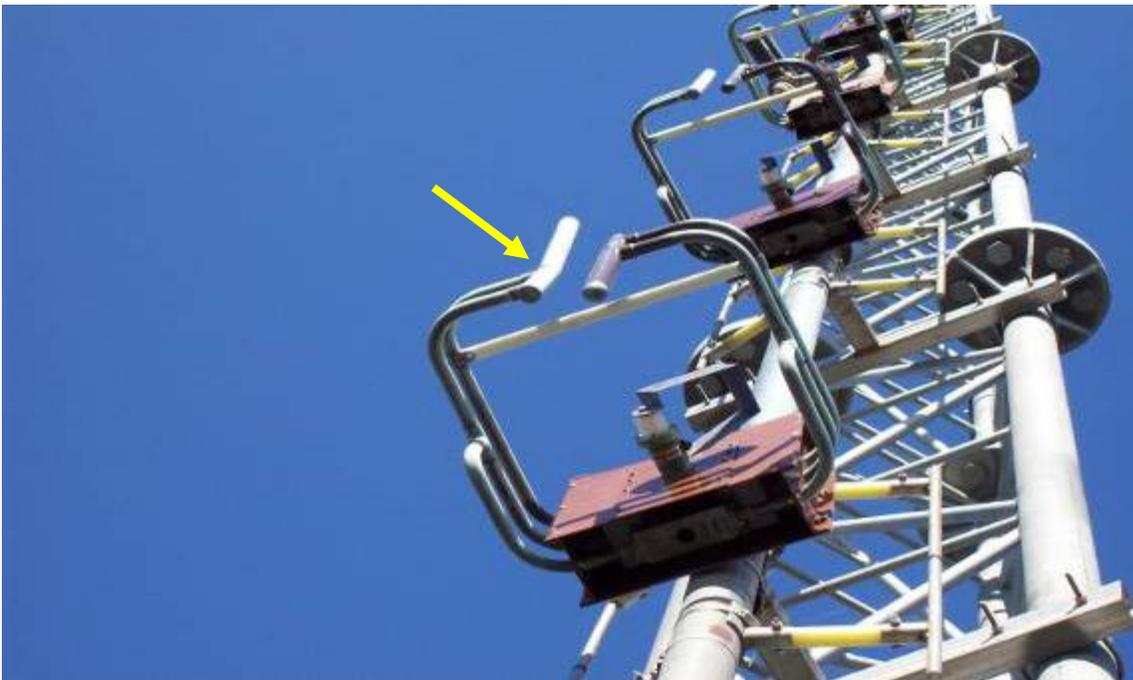
Photos show the two damaged FM antenna bay elements.

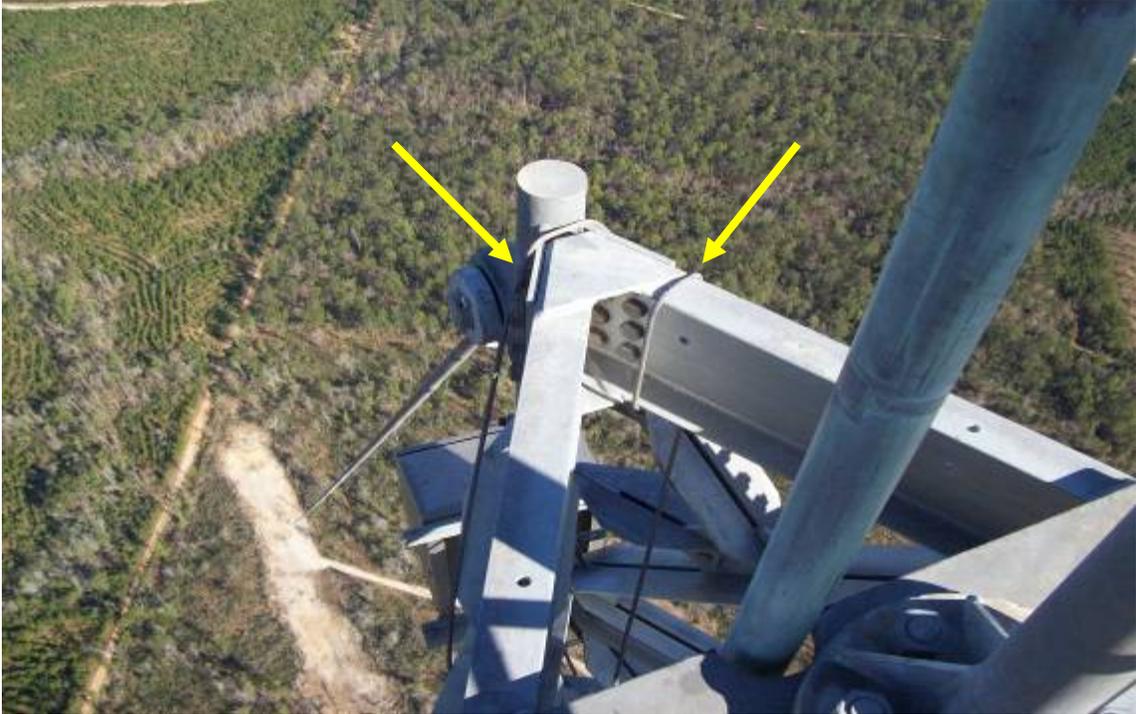
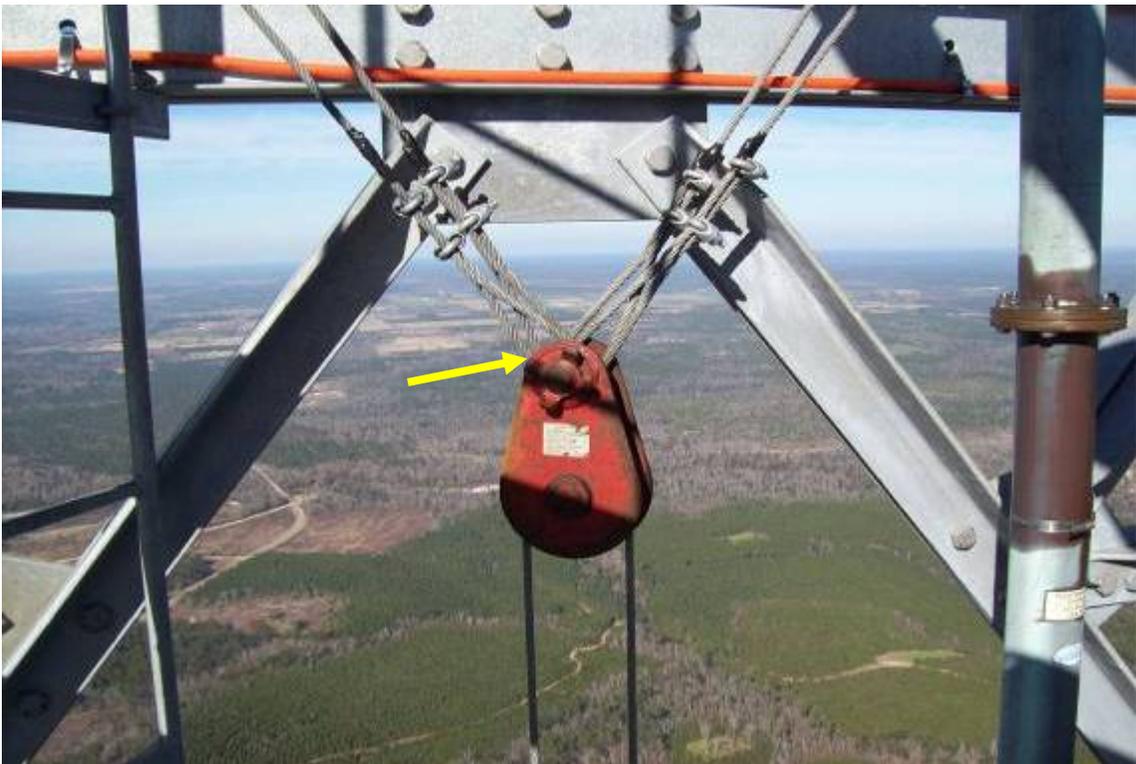
Photos show rigging left at the top of the tower in Section #73

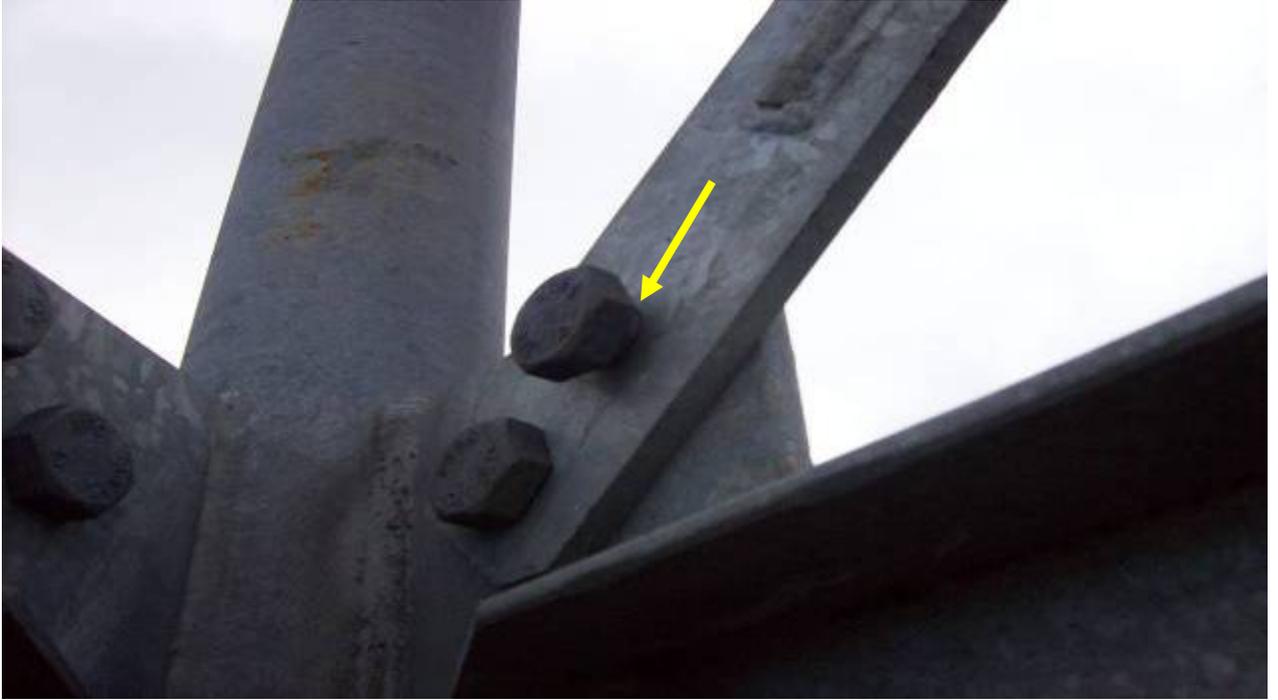
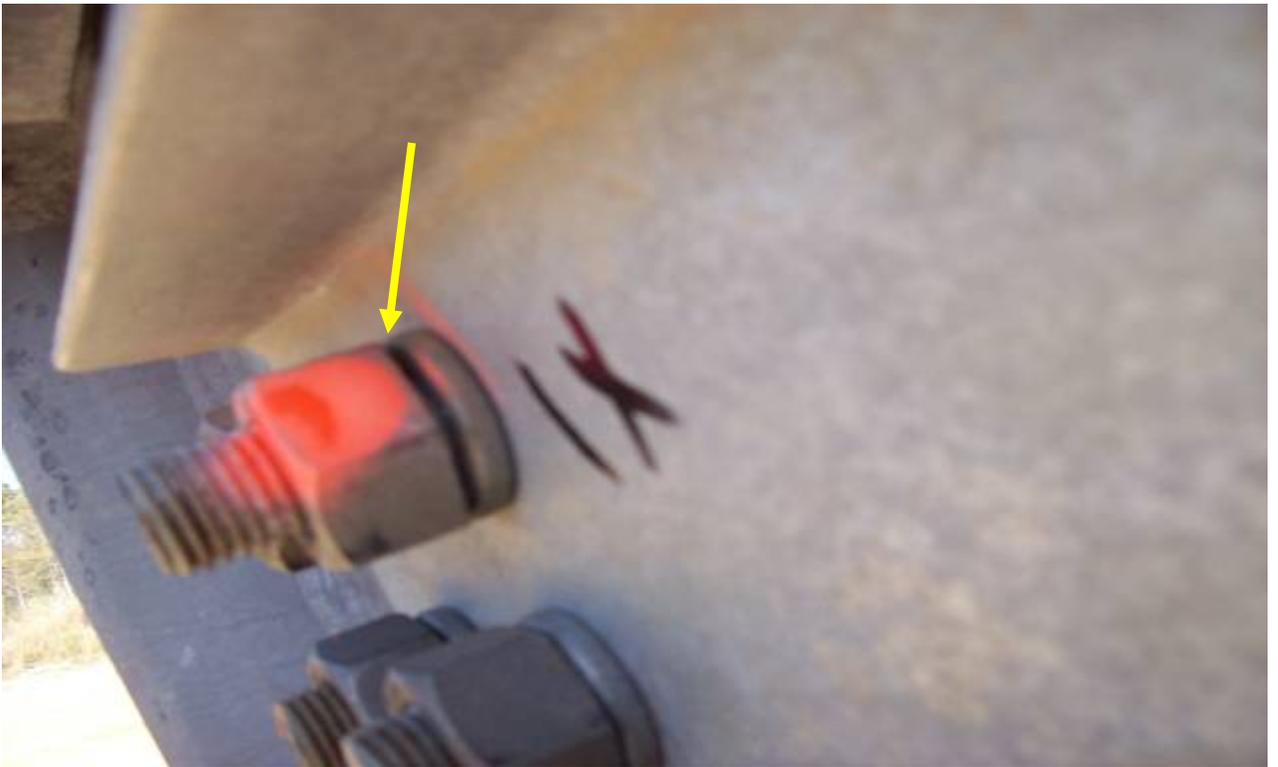
Photos show loose structural member connection bolts.

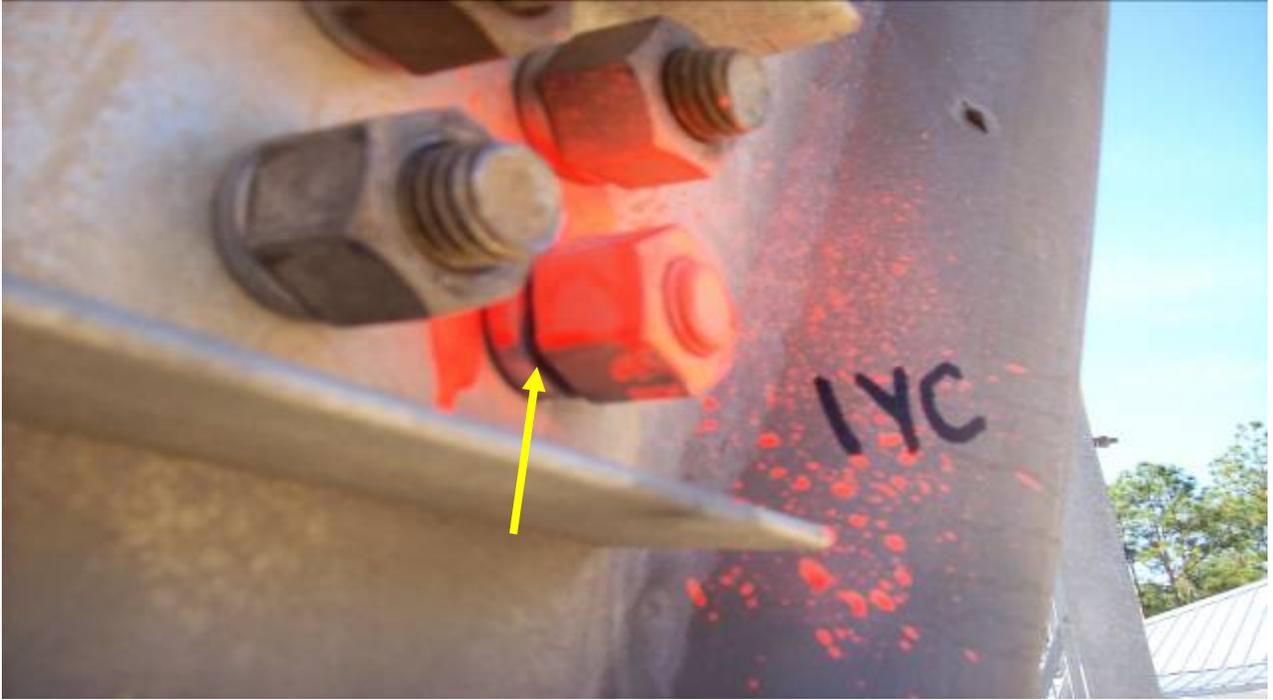
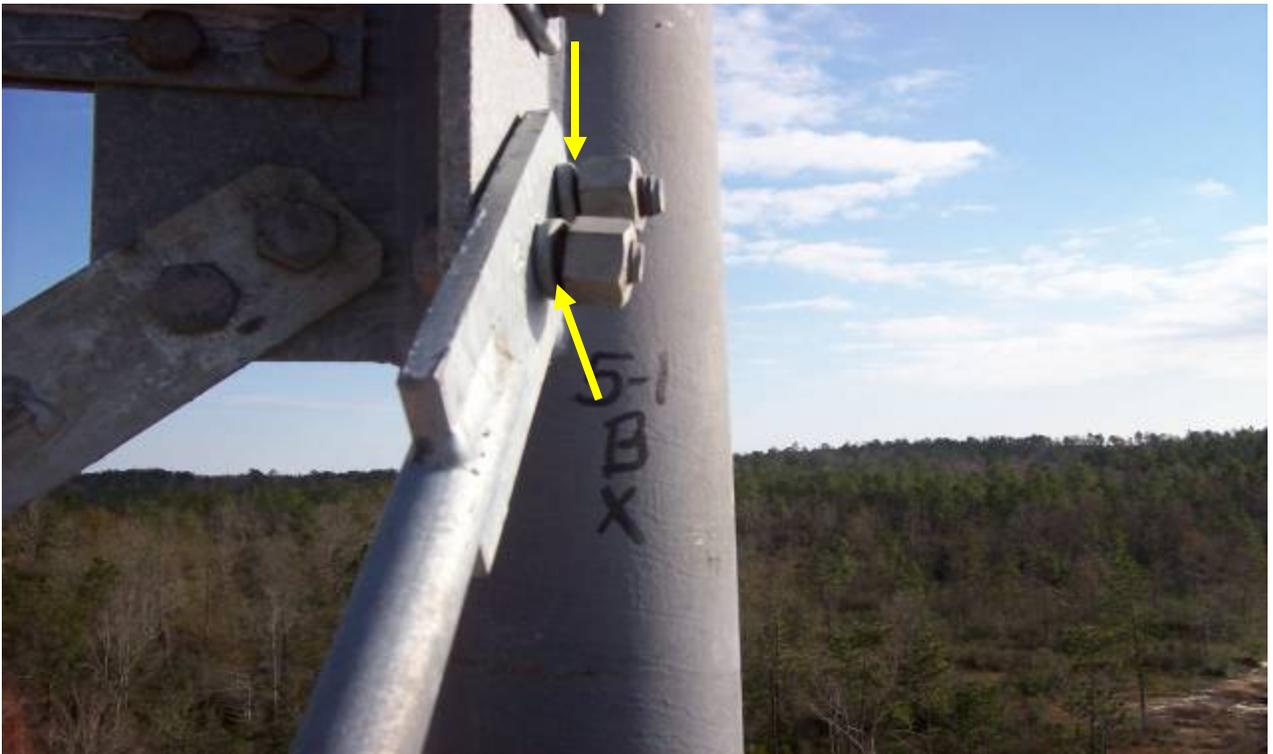
Photos show loose structural member connection bolts.

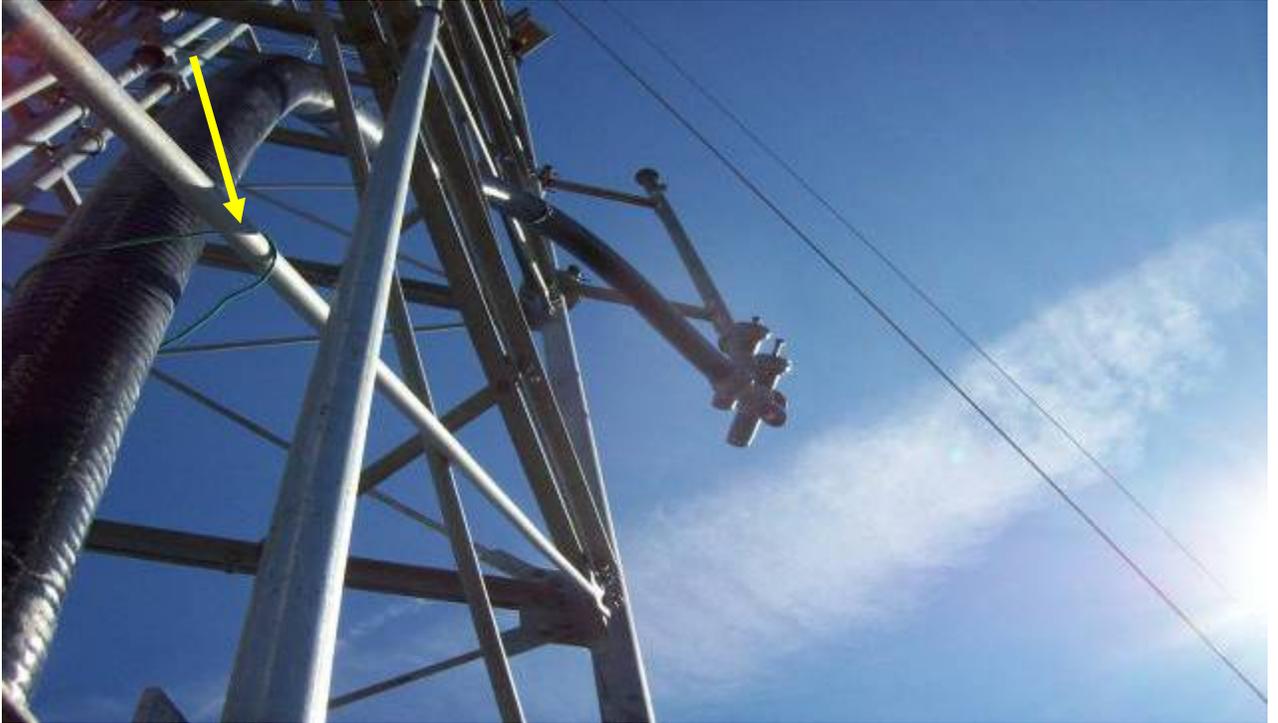
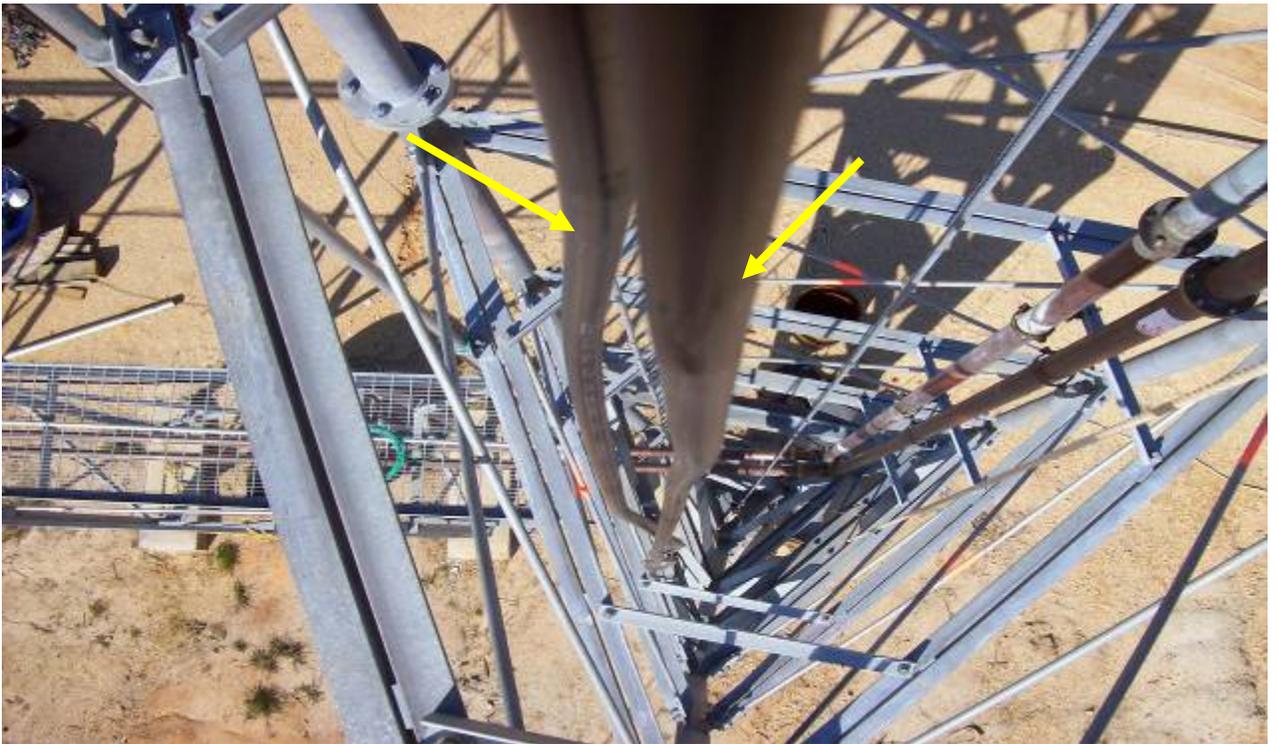
Photos show typical loose flexible type transmission lines.

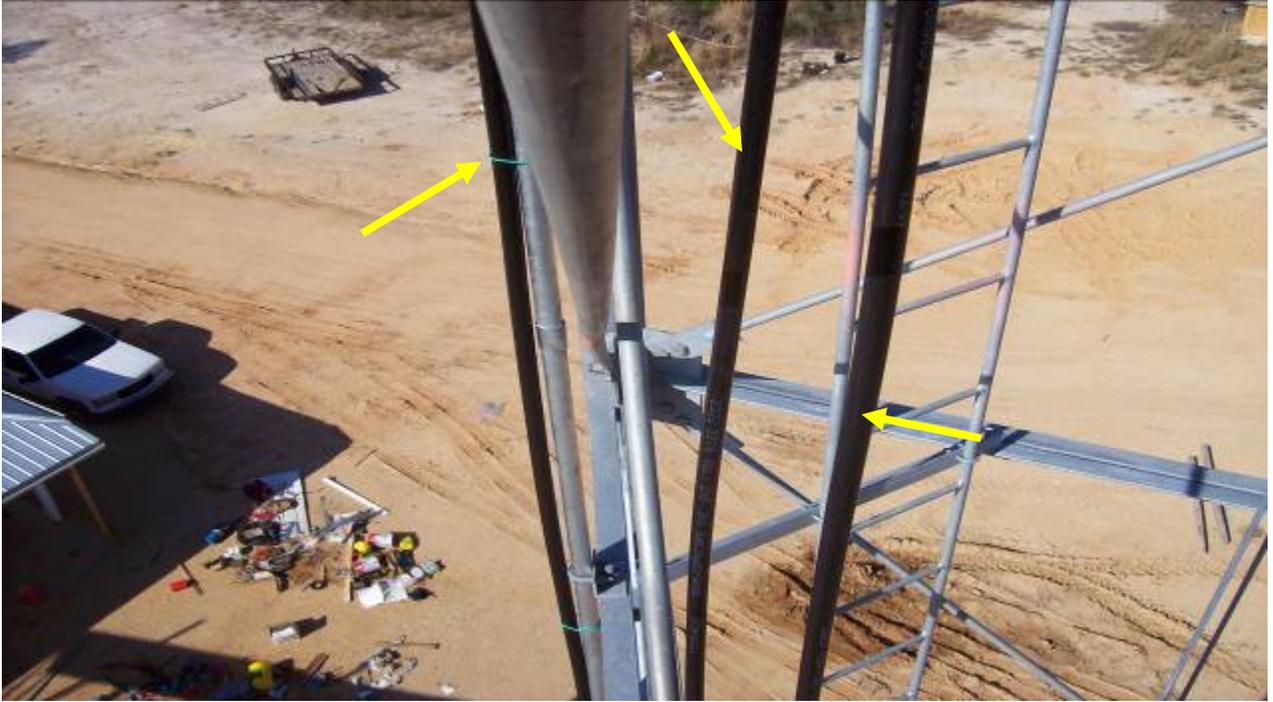
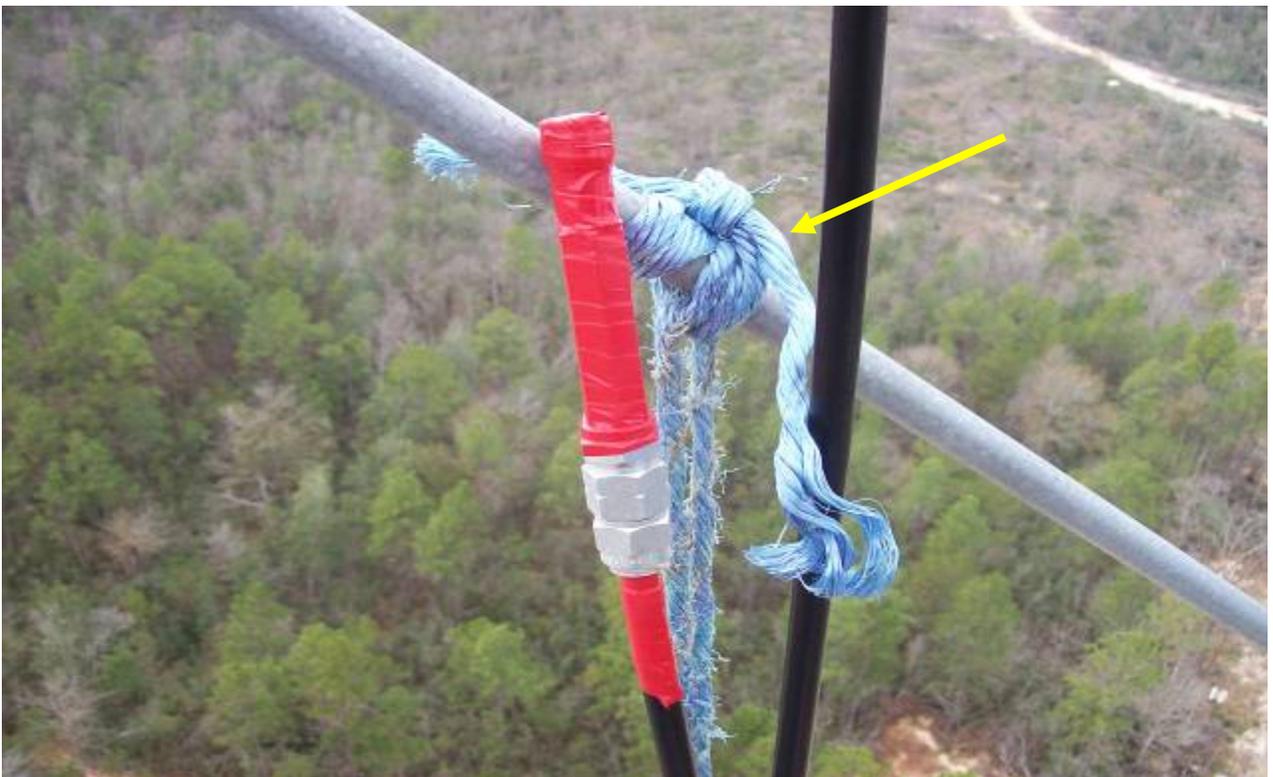
Photos show typical loose and improperly secured flexible type transmission lines.
