3010 S. Hwy 77, Suite 600
Waxahachie, Texas 75165
<http://ctctower.com>
Office: 972/923-9504
Fax: 972/923-9619

TOWER INSPECTION REPORT

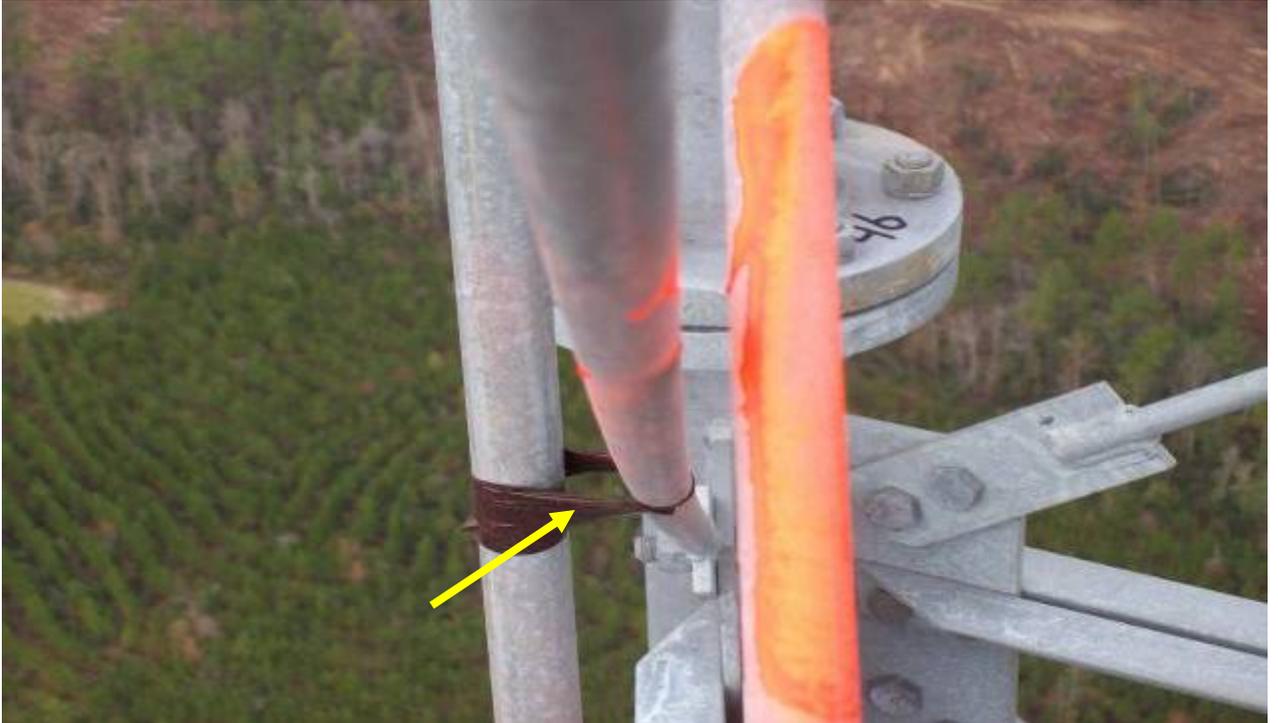
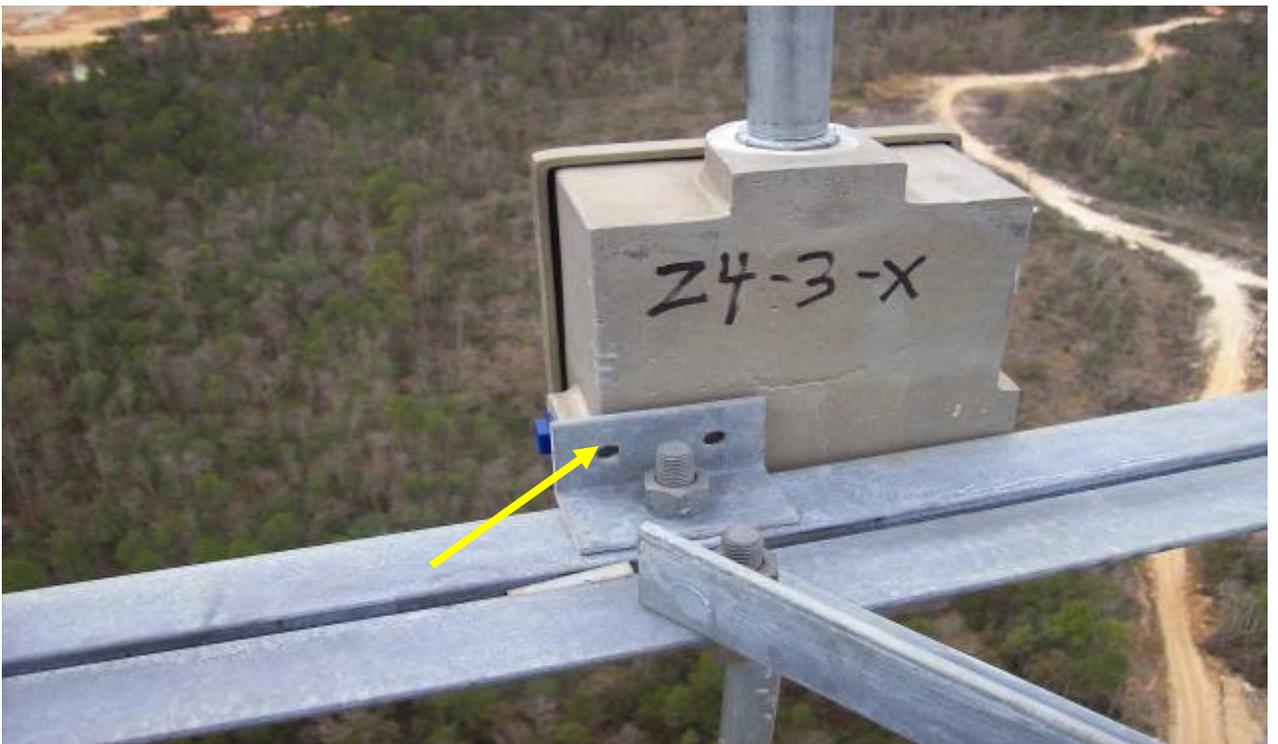
Photos show typical conduit improperly secured.

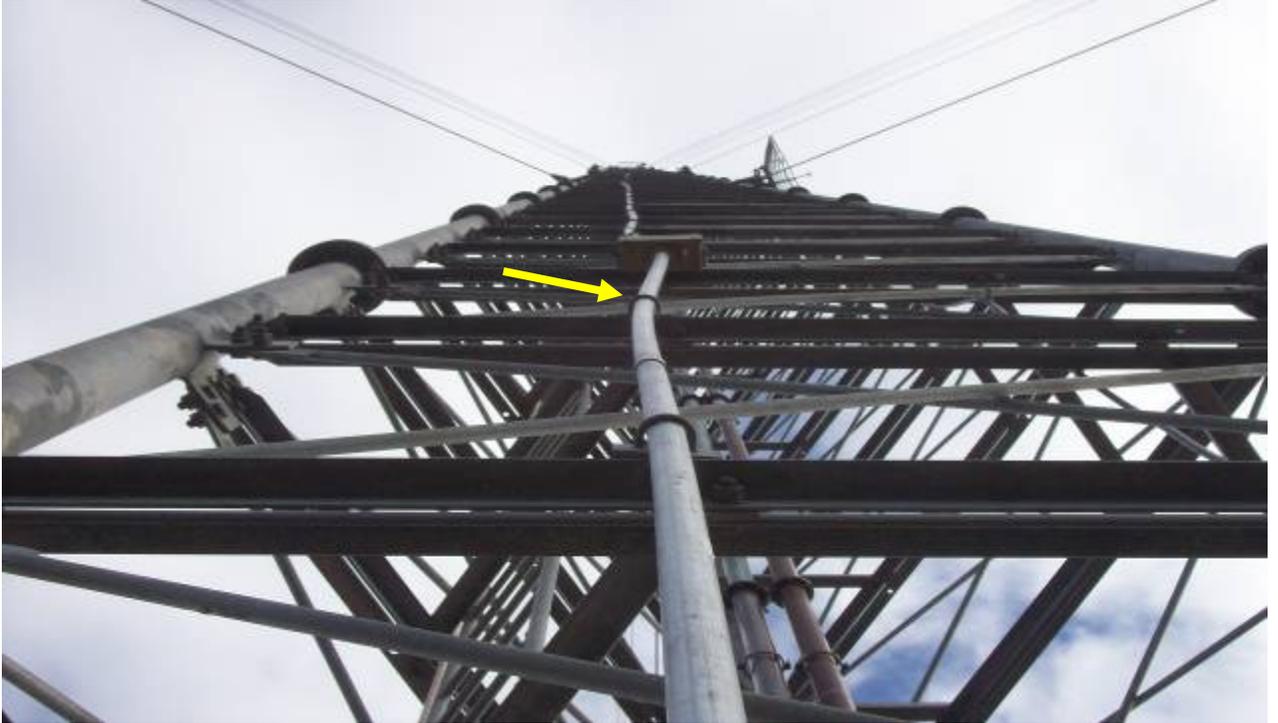
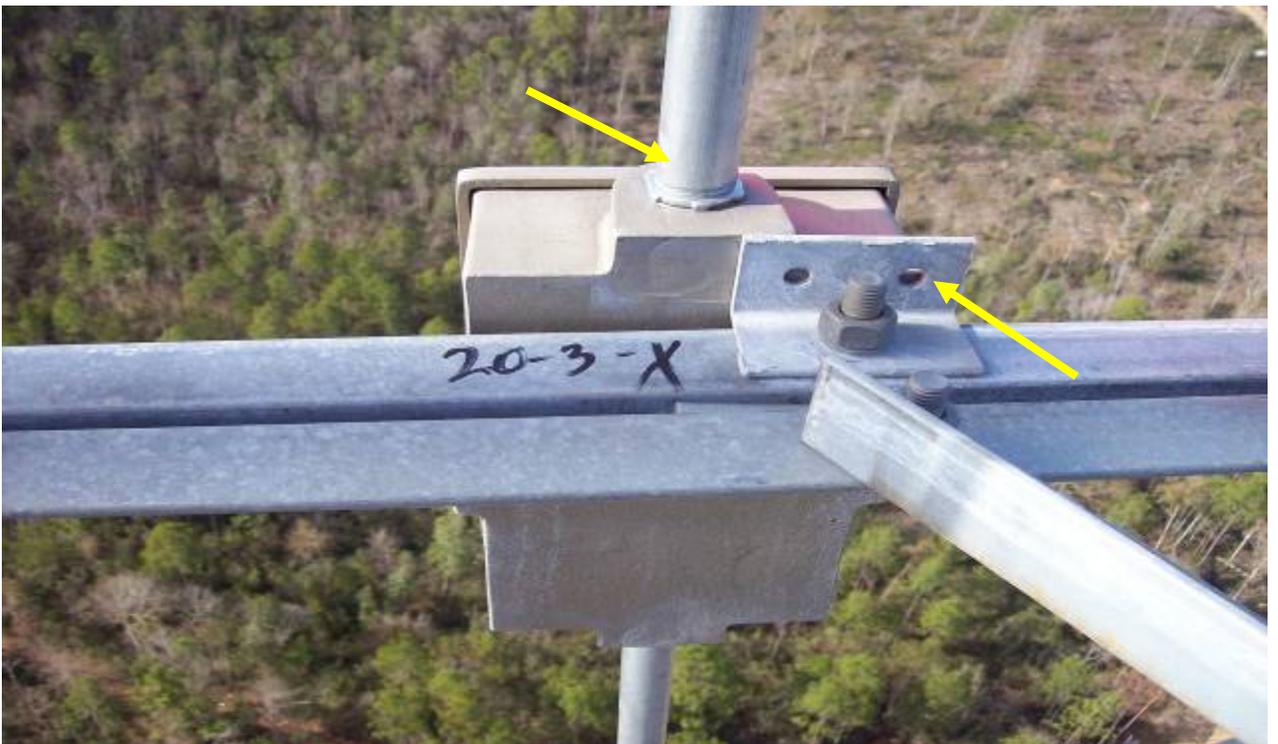
Photos show typical conduit improperly secured. Note: the conduit is binding up and bending due to the missing expansion joints.

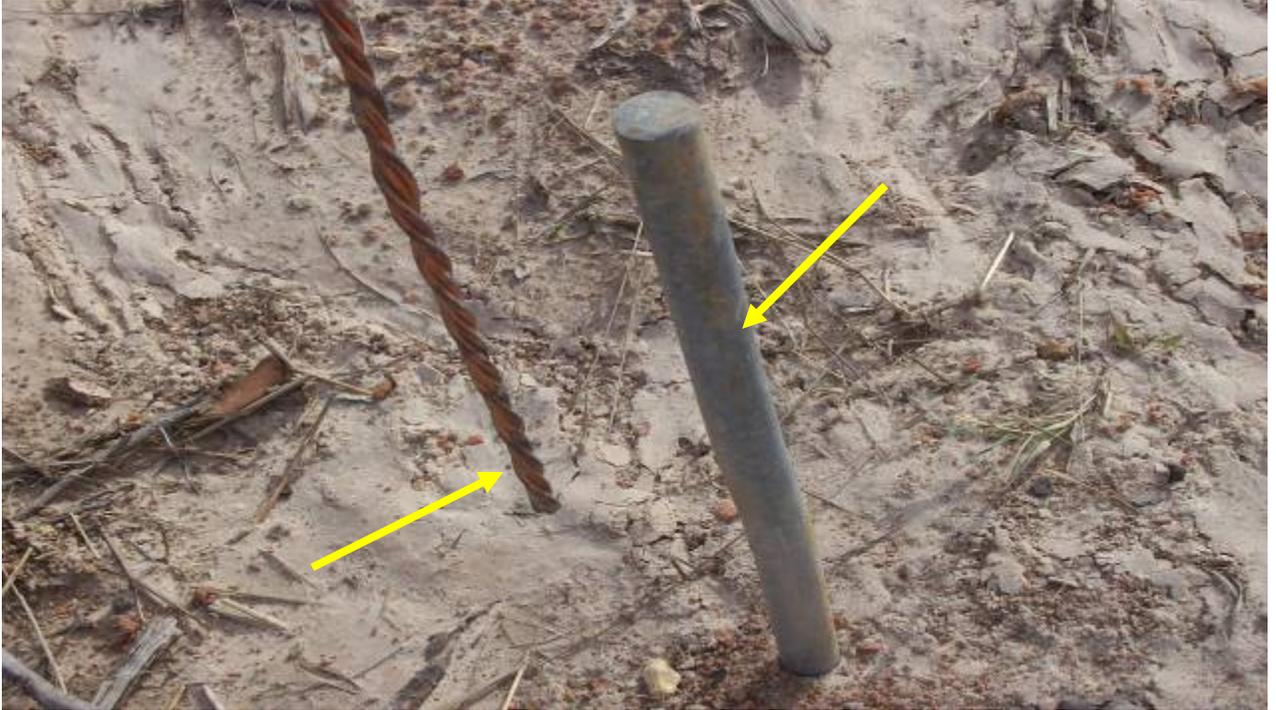
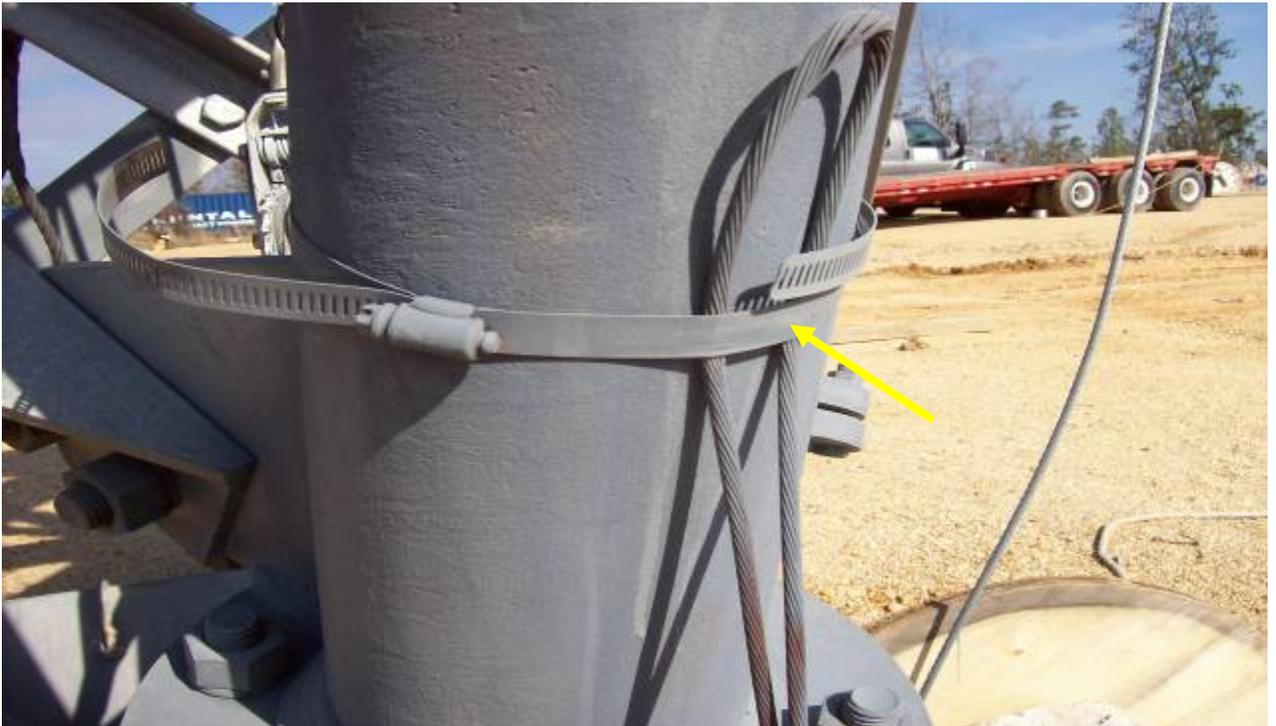
Photos show guy wire grounding cable that is not attached to the grounding rod and the grounding cable that is improperly attached to the tower base.

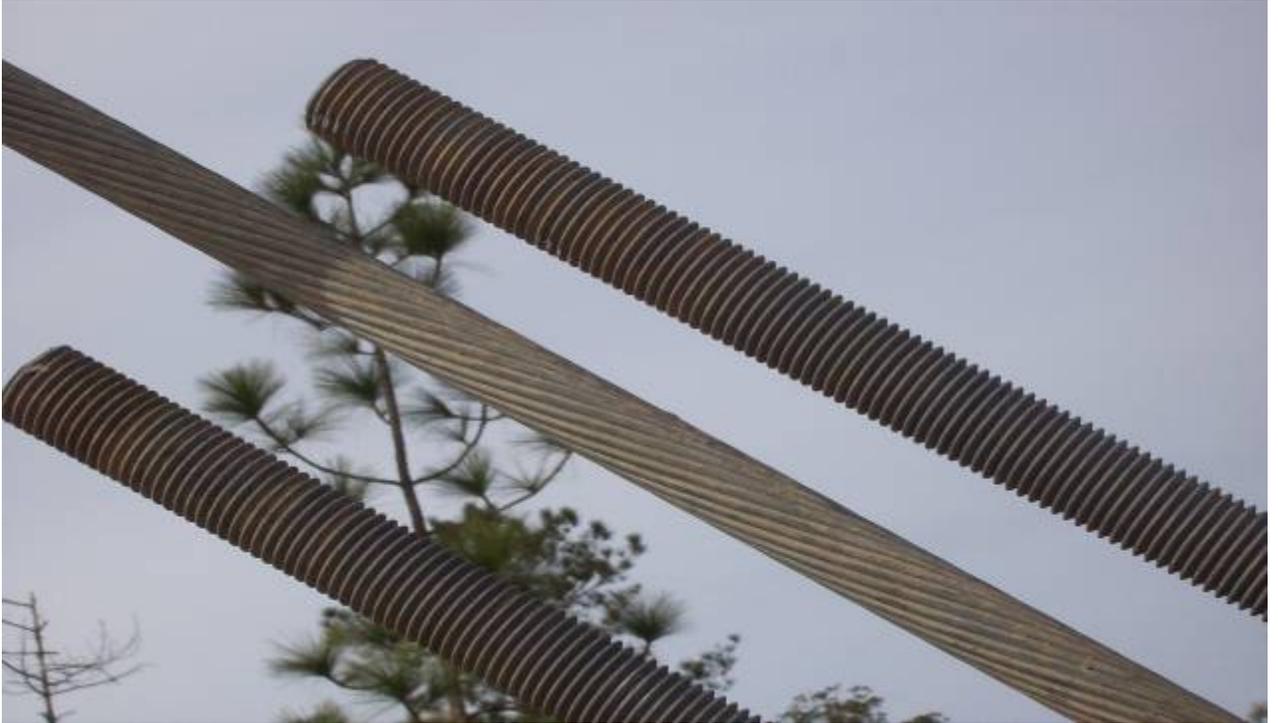
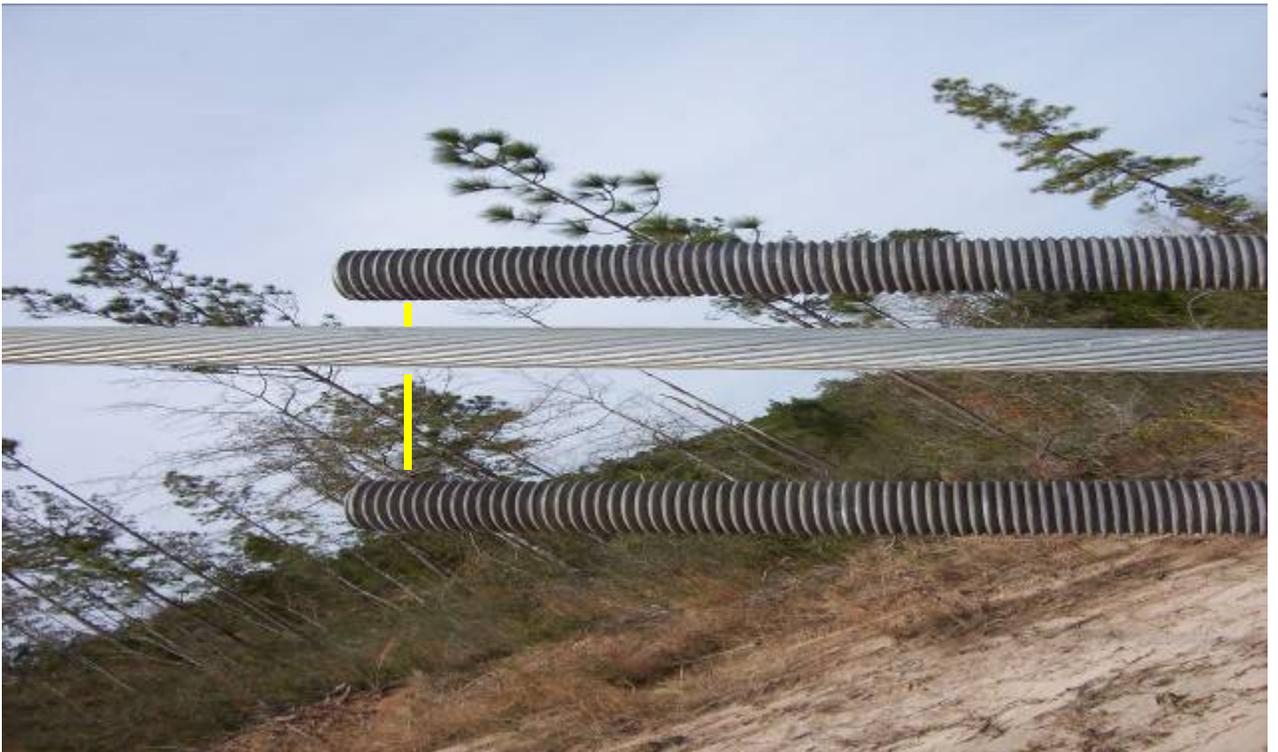
Photos show the typical unequally balanced sockets on the hairpins.

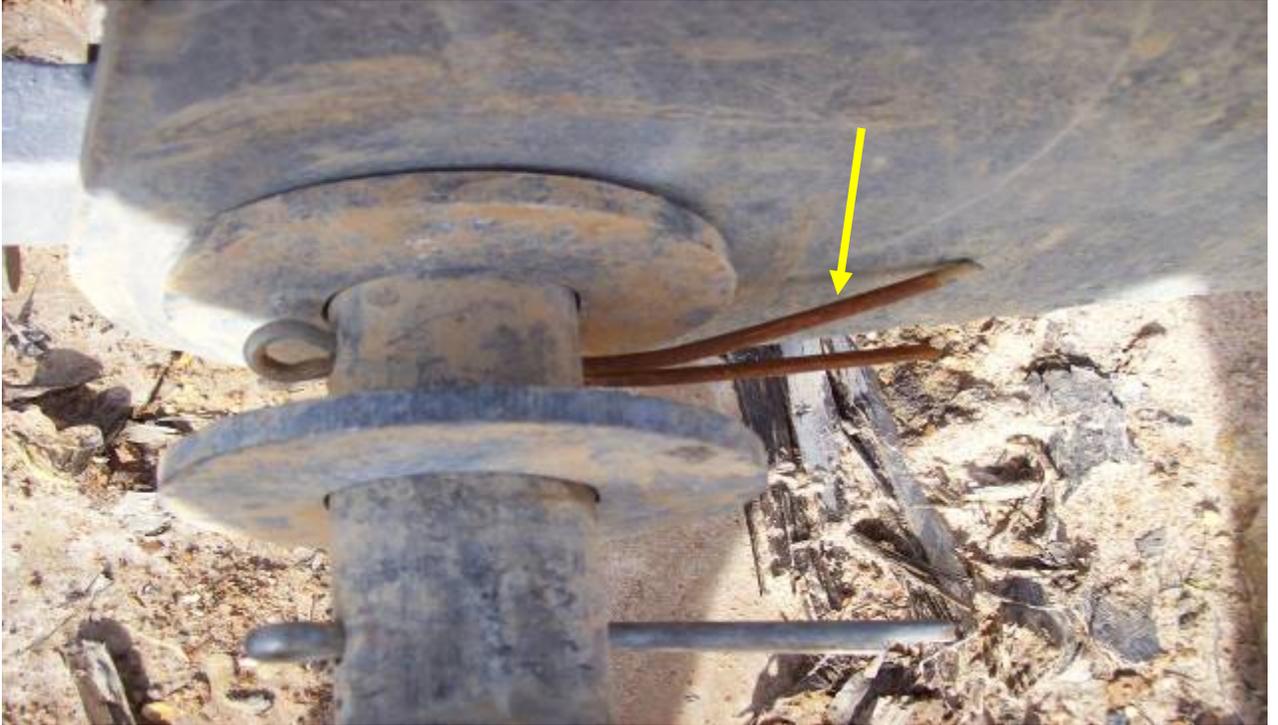
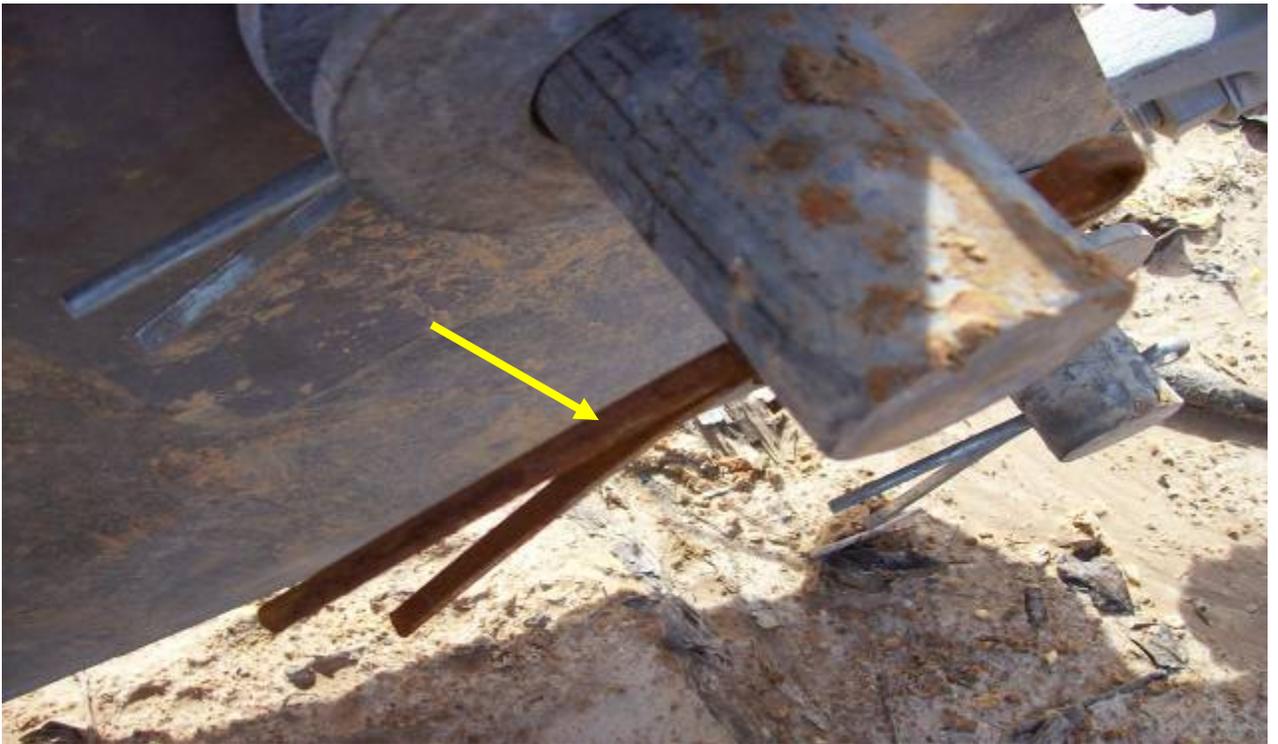
Photos show typical rusting safety cotter pins on anchor pins.

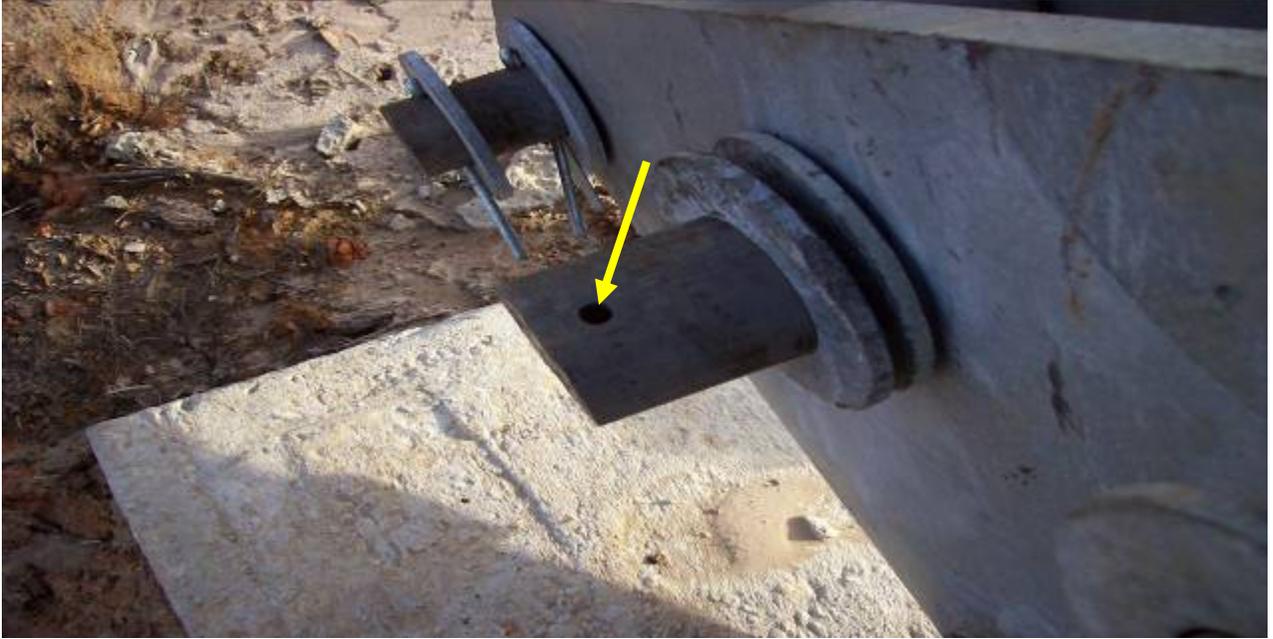
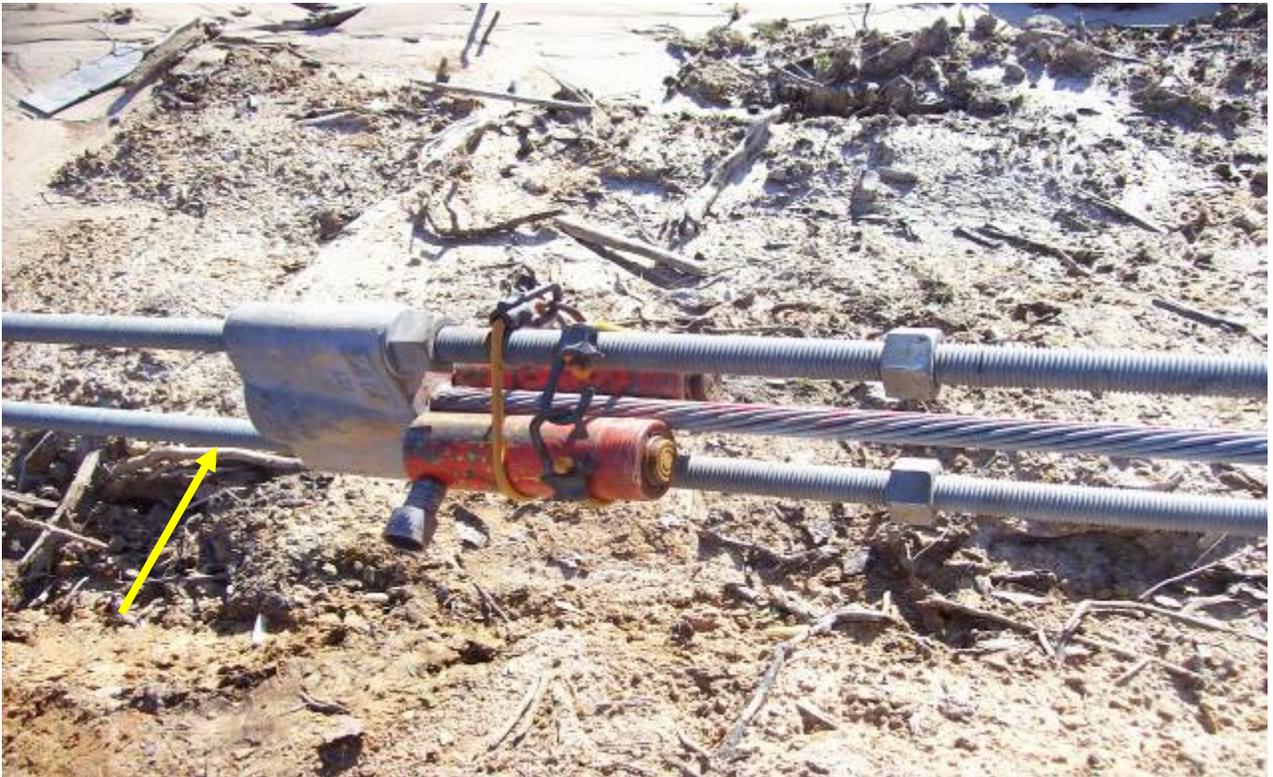
Photos show a missing safety cotter pin on an anchor pin and the #1 level guy wire hairpin at Anchor C-1 that is lying just above the ground.

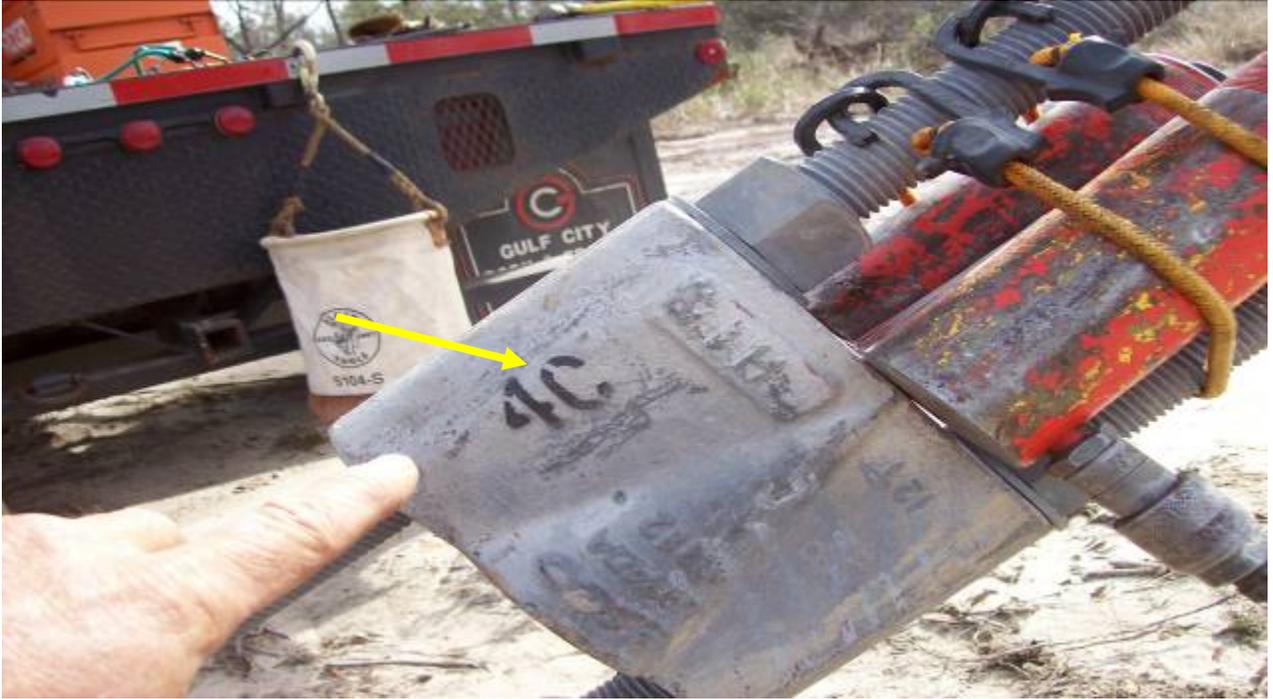
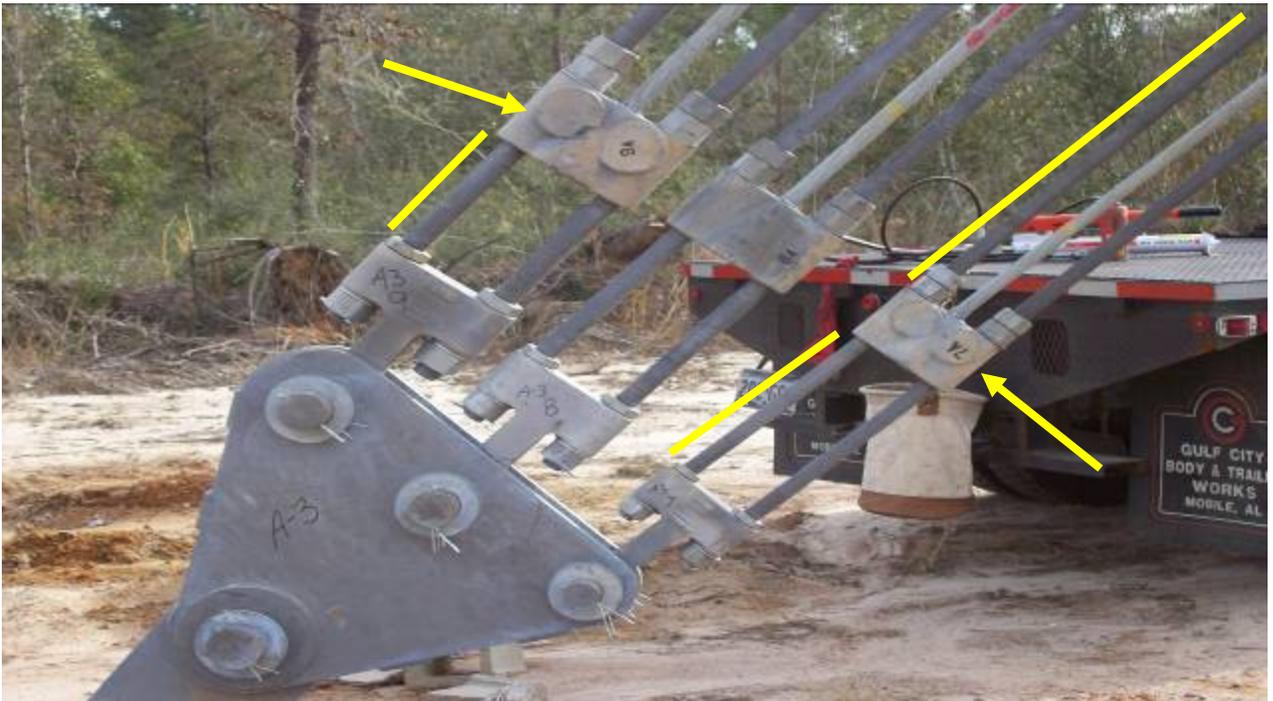
Photos show incorrect installation of guy wire 4-C installed at Anchor 4-A (tensions were check at A anchors) and limited room for guy wire adjustment on the hairpins at Anchor A-3 due to improper installation.

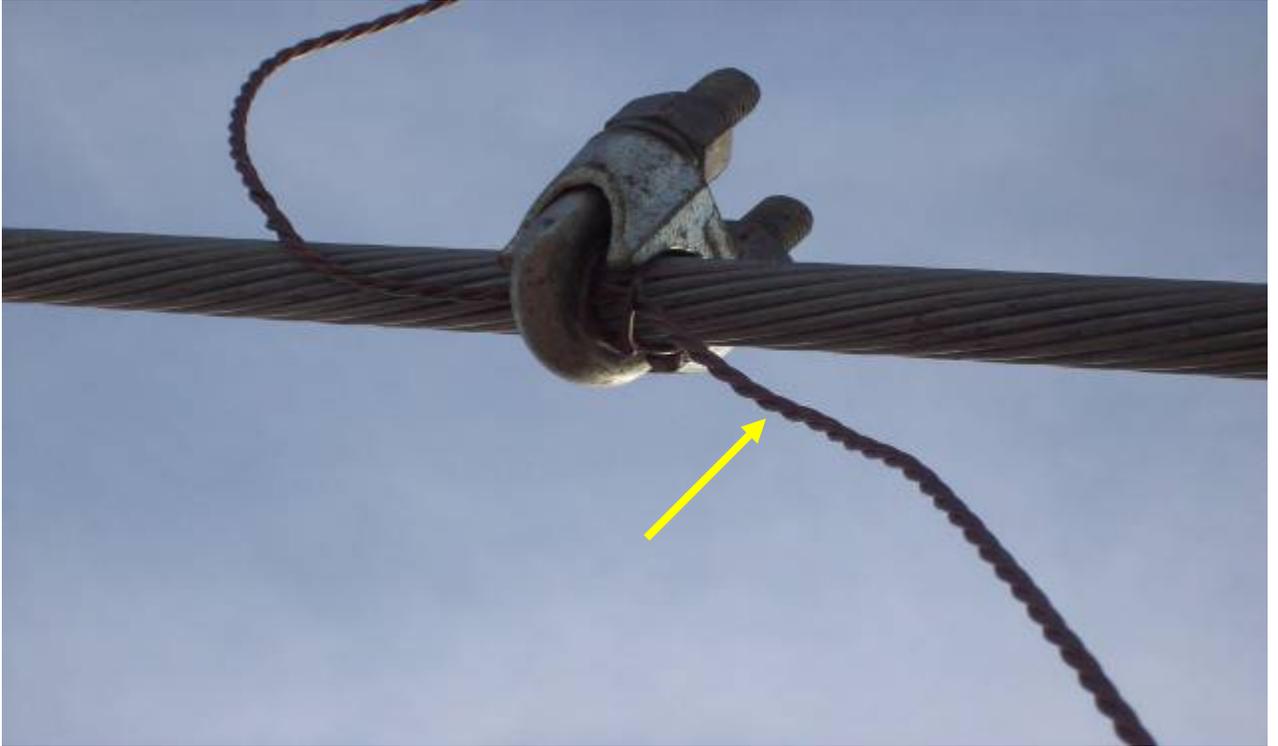
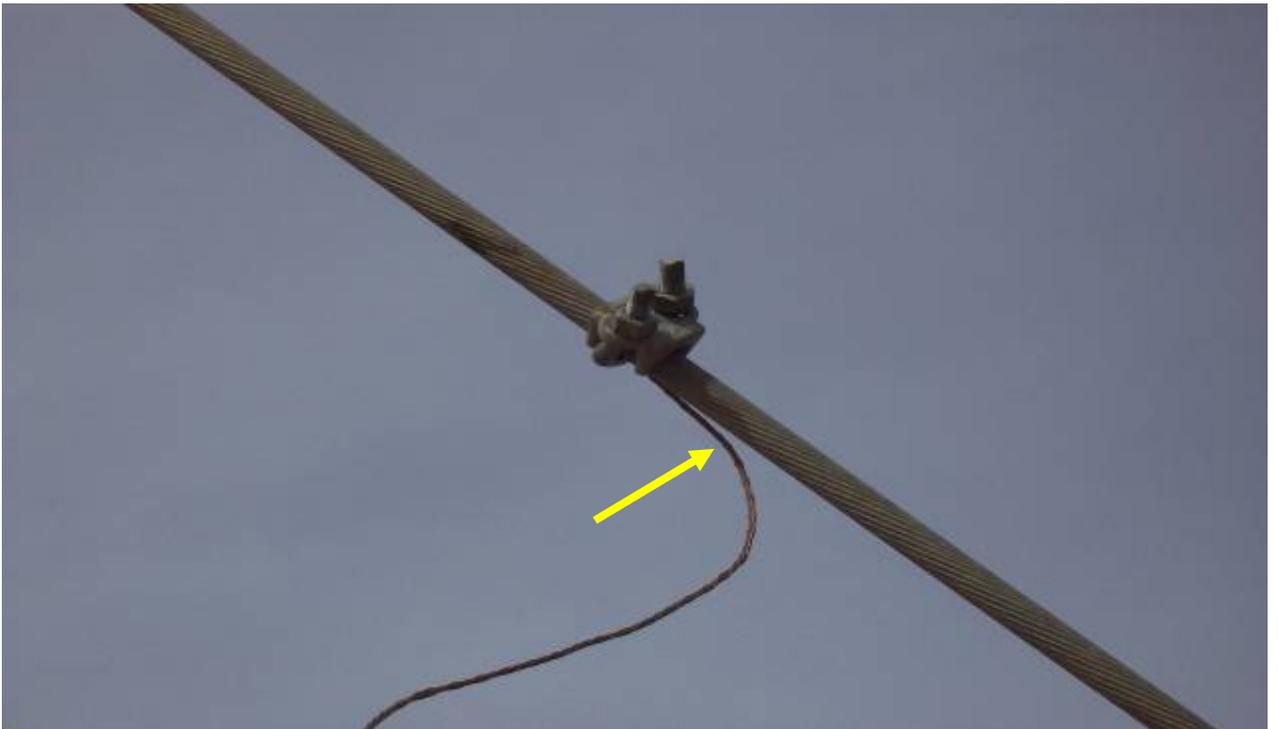
Photos show the improper use of copper grounding cable on galvanized wire.

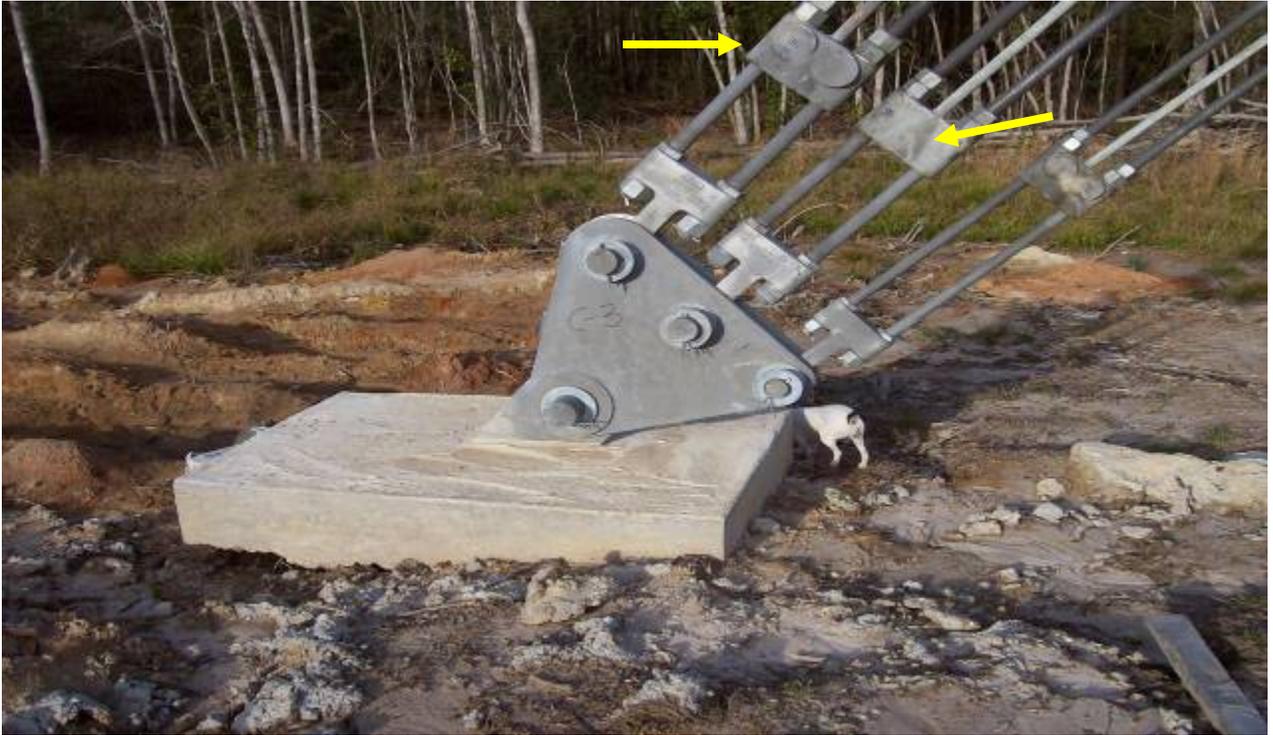
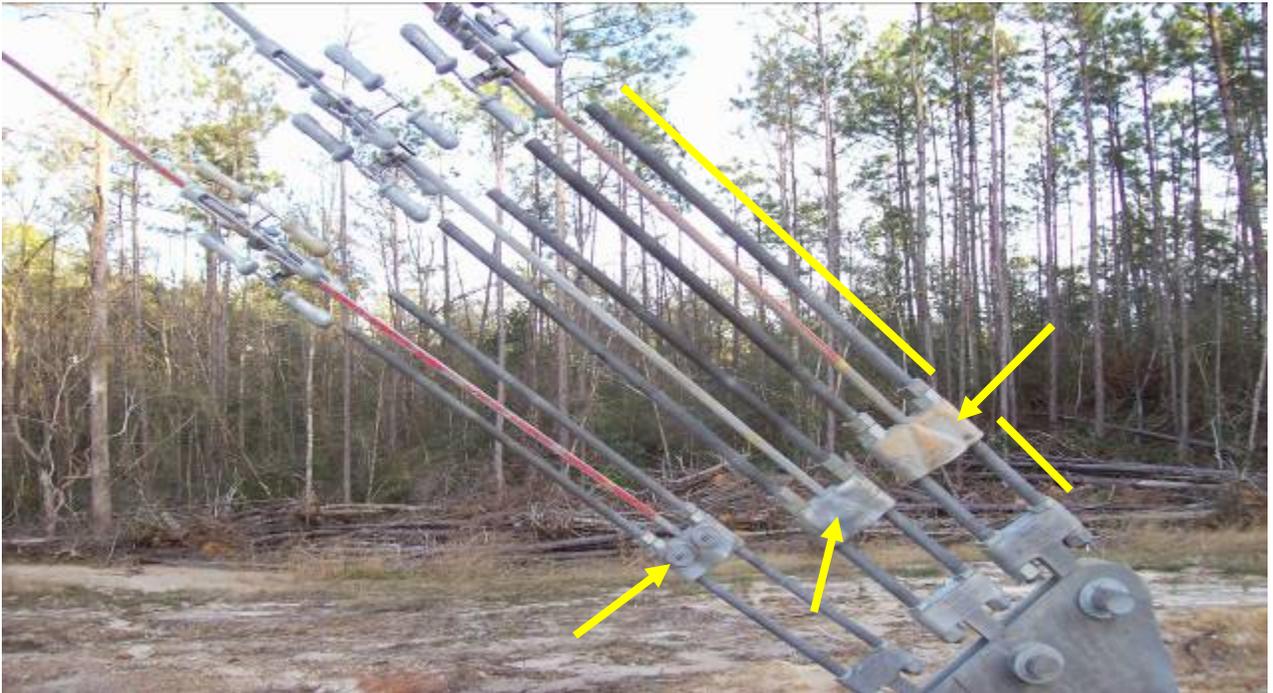
Photos show and limited room for guy wire adjustment on the hairpins due to improper installation.

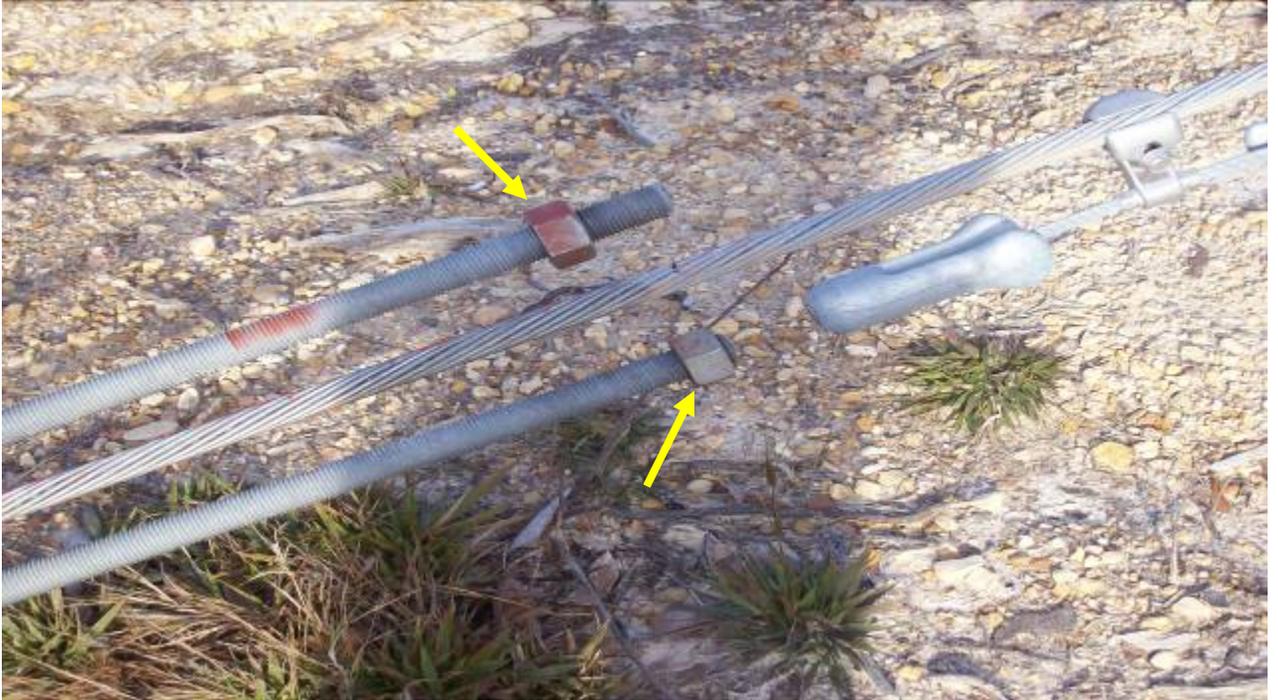
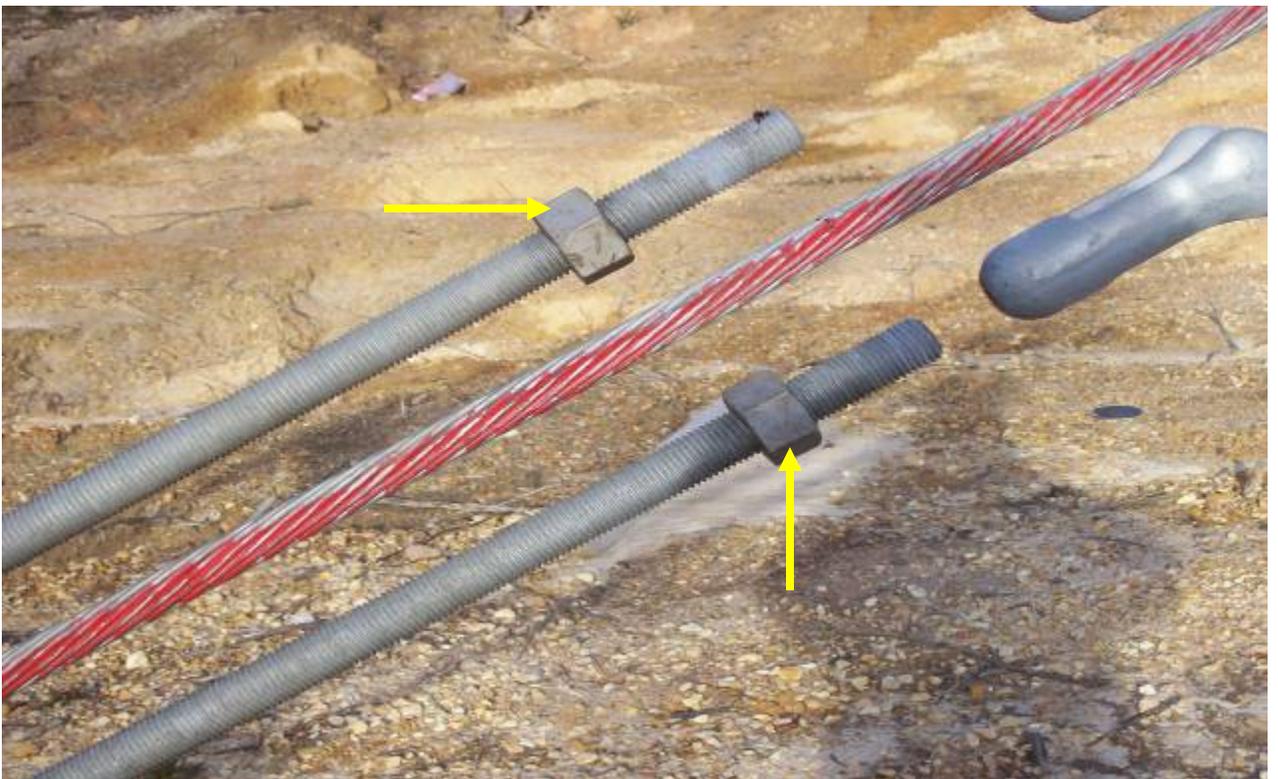
Photos show loose safety nuts on guy wire hairpins.

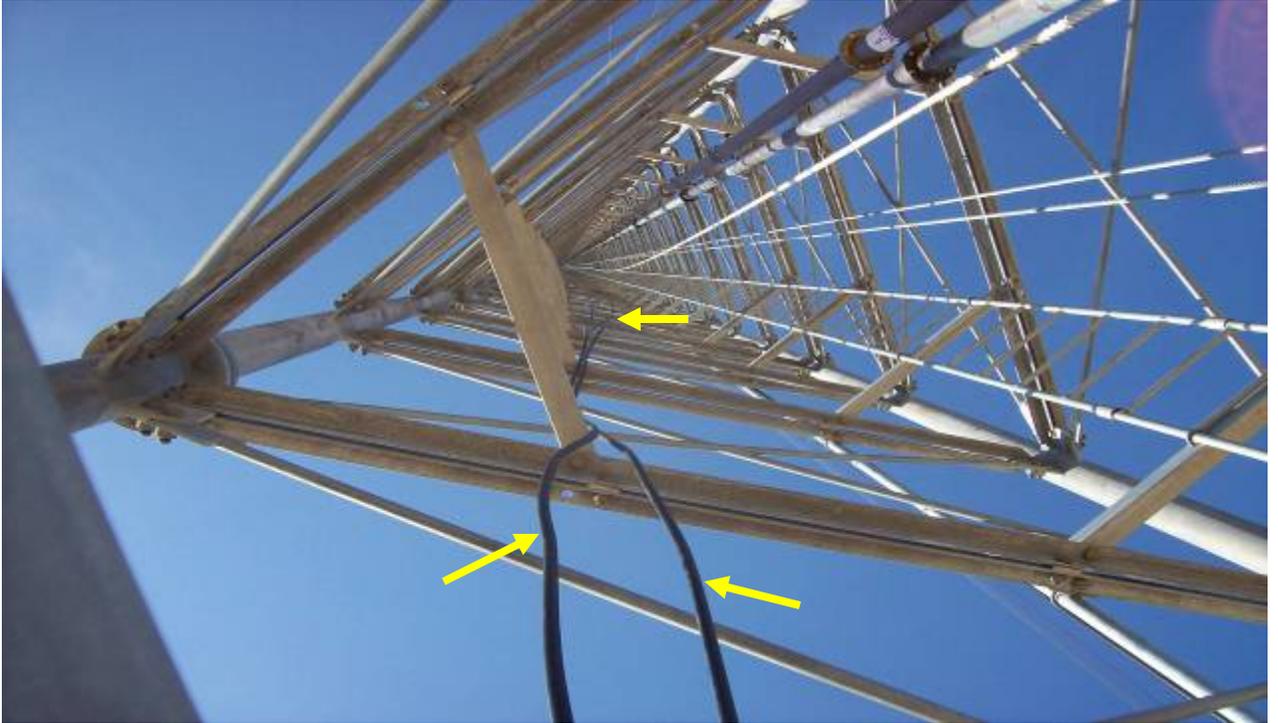
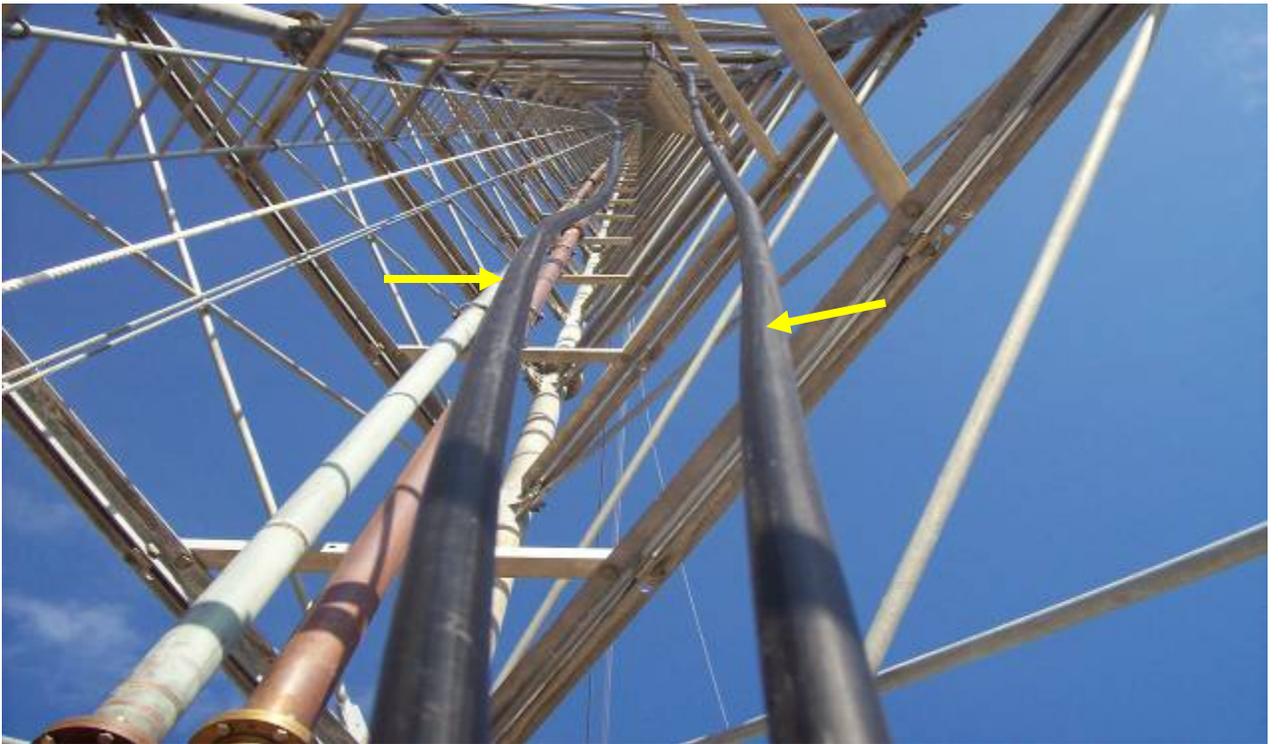
Photos show typical unsecured small flex lines.

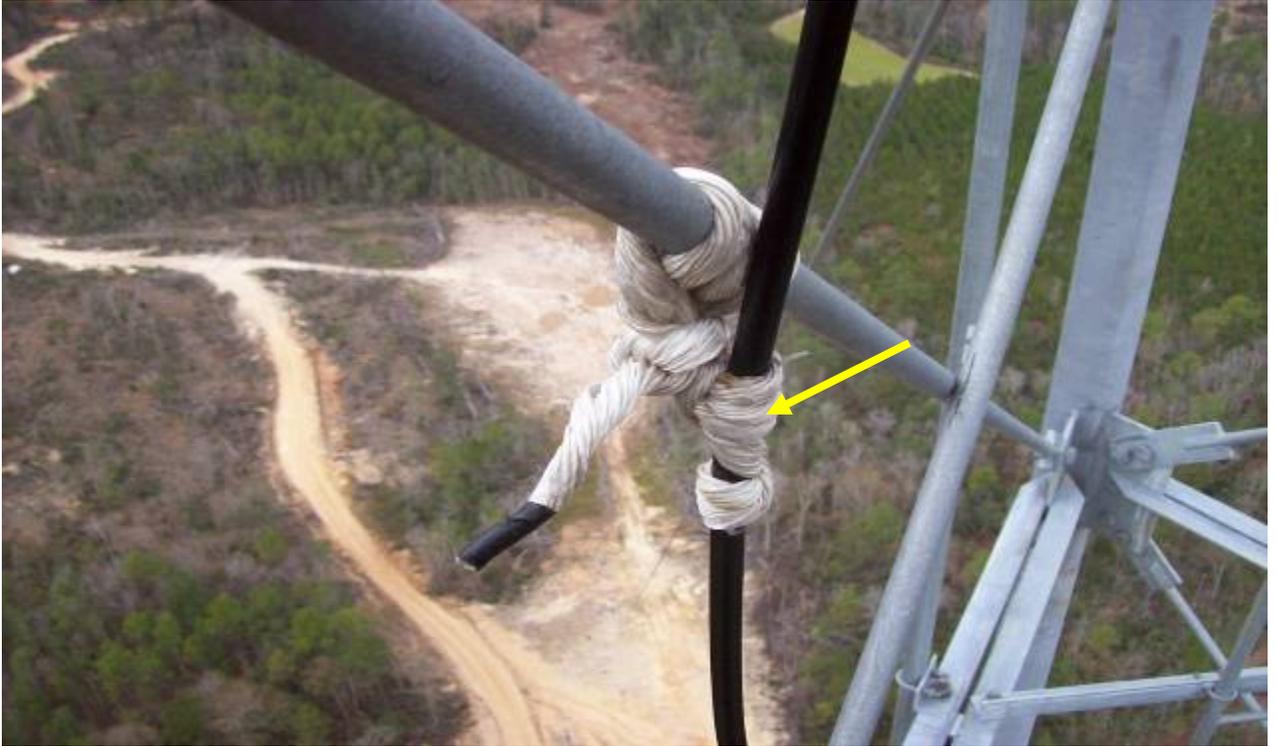
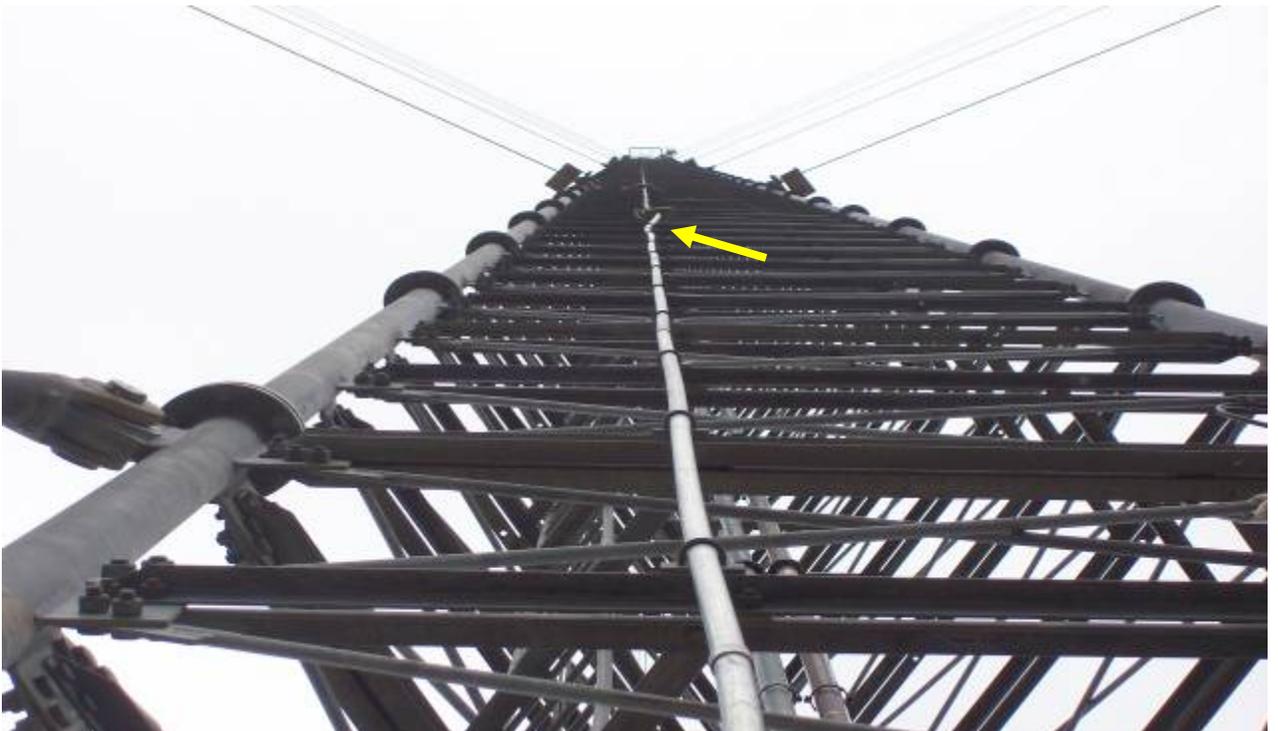
Photos show typical improperly secured small flex lines and the misaligned conduit.
