3010 S. Hwy 77, Suite 600
Waxahachie, Texas 75165
<http://ctctower.com>
Office: 972/923-9504
Fax: 972/923-9619

TOWER INSPECTION REPORT

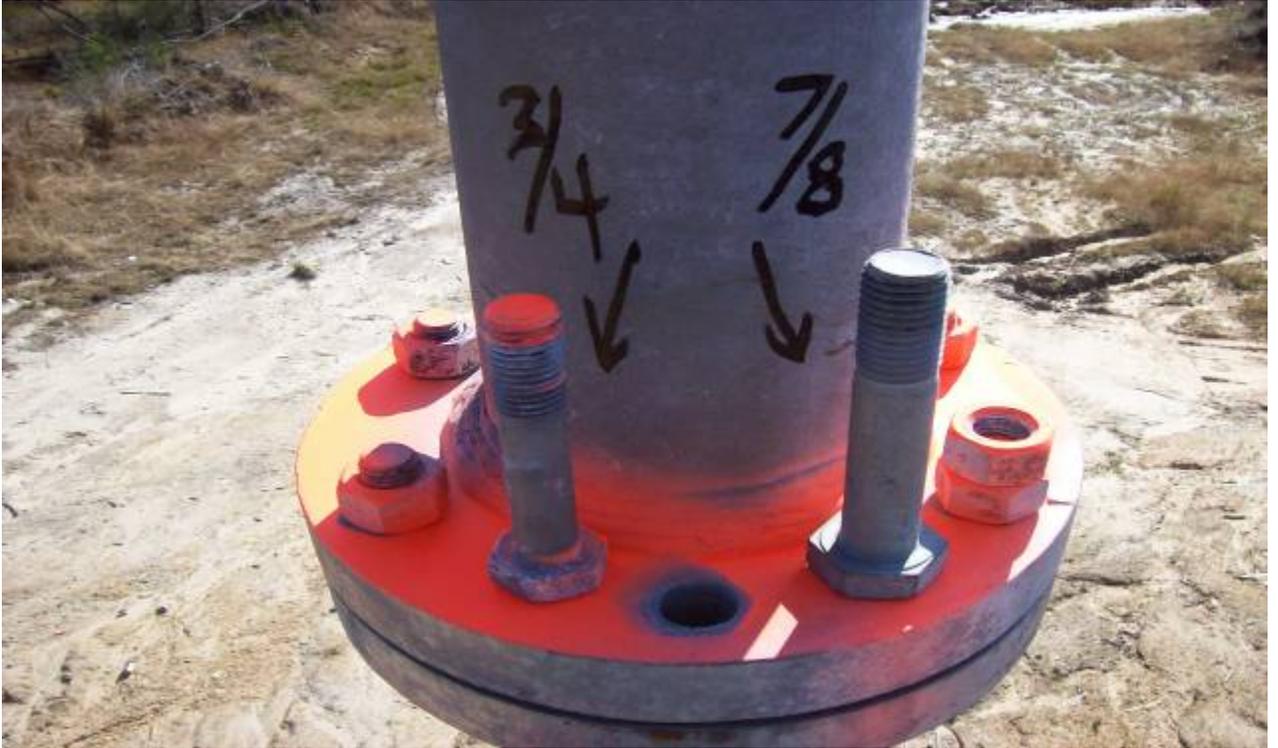
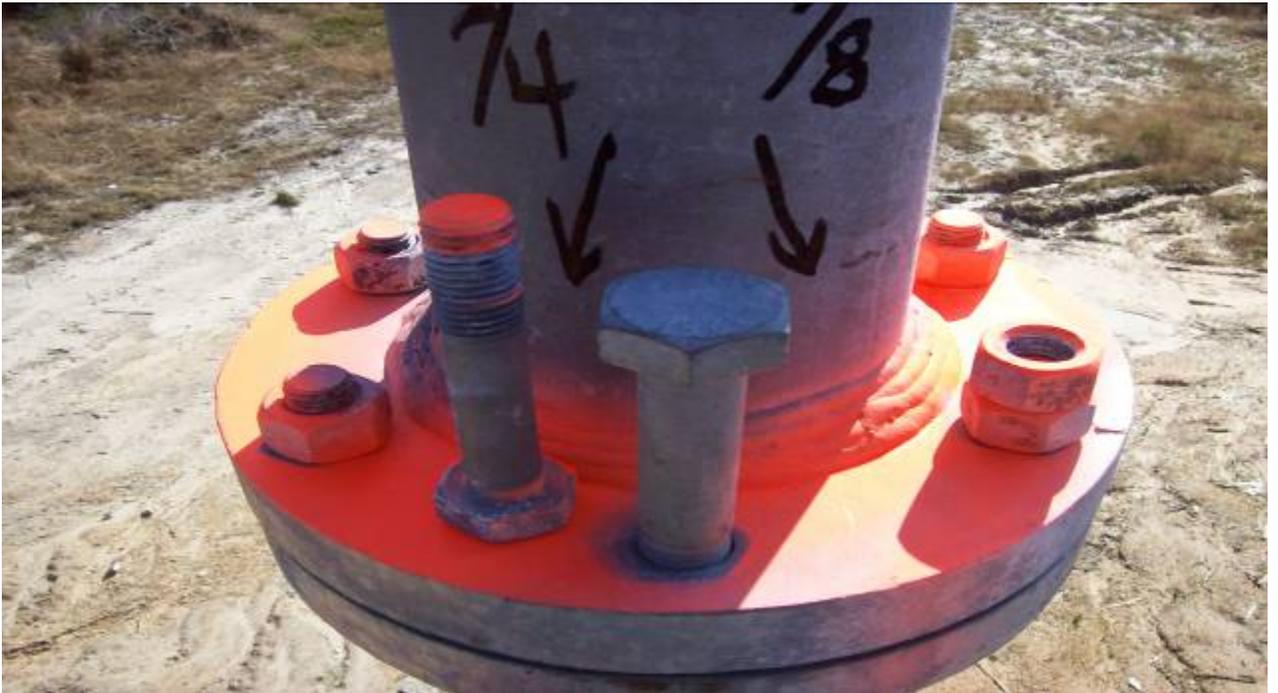
Photos show leg pads drilled for 7/8" bolts, but with 3/4" bolts installed.

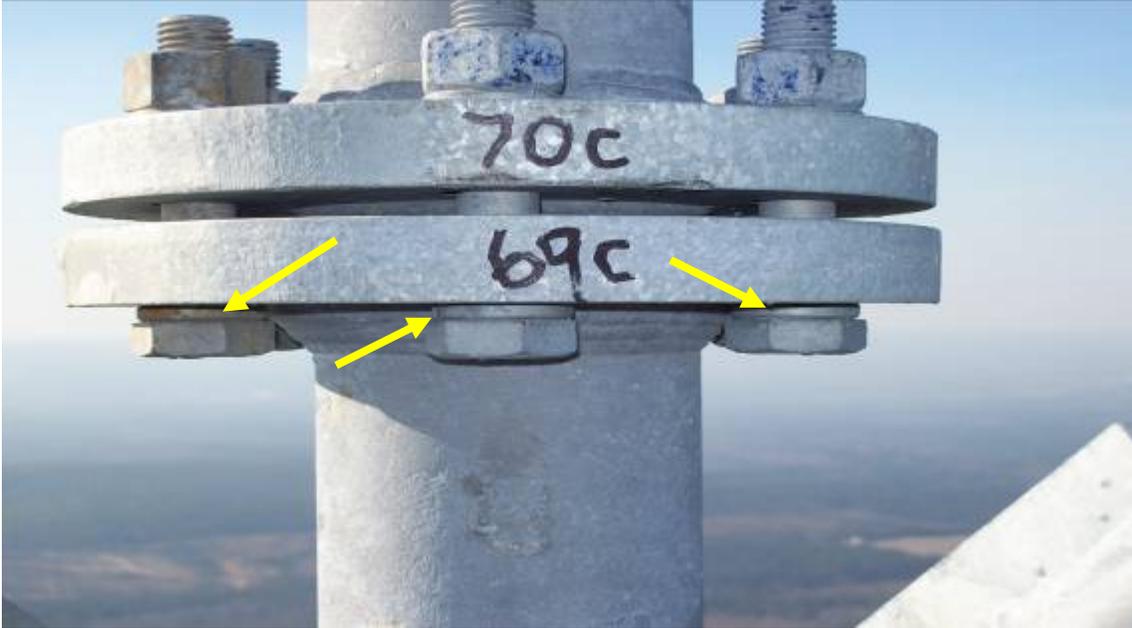
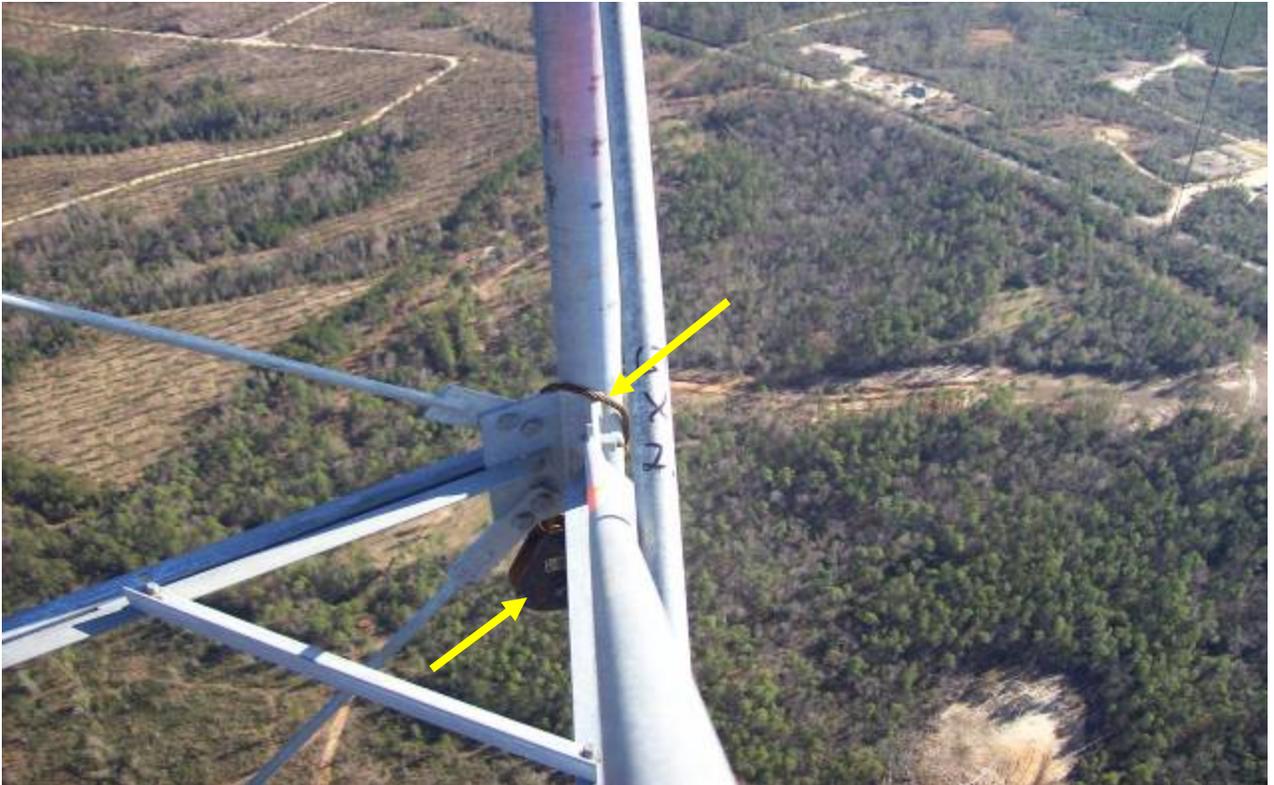
Photos show leg pad bolts with washers improperly installed under the bolt head and abandoned rigging.

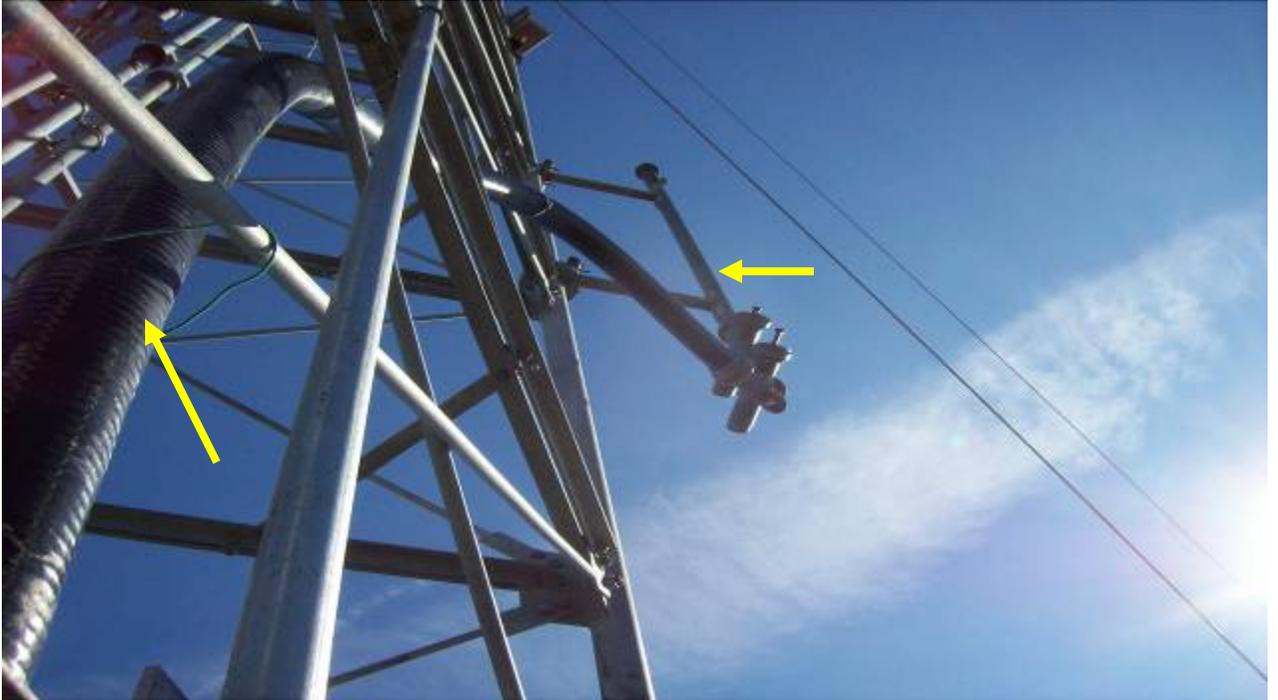
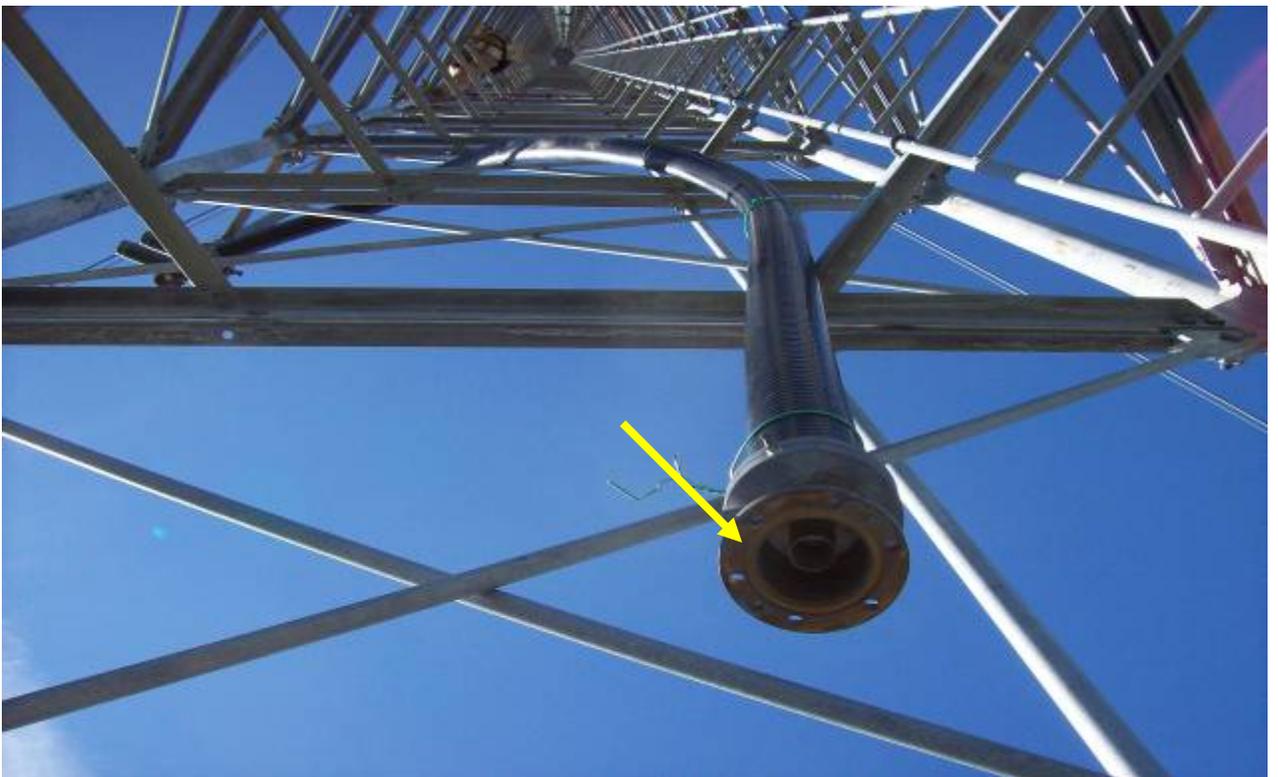
Photos show the unused antenna and flexible coax line.

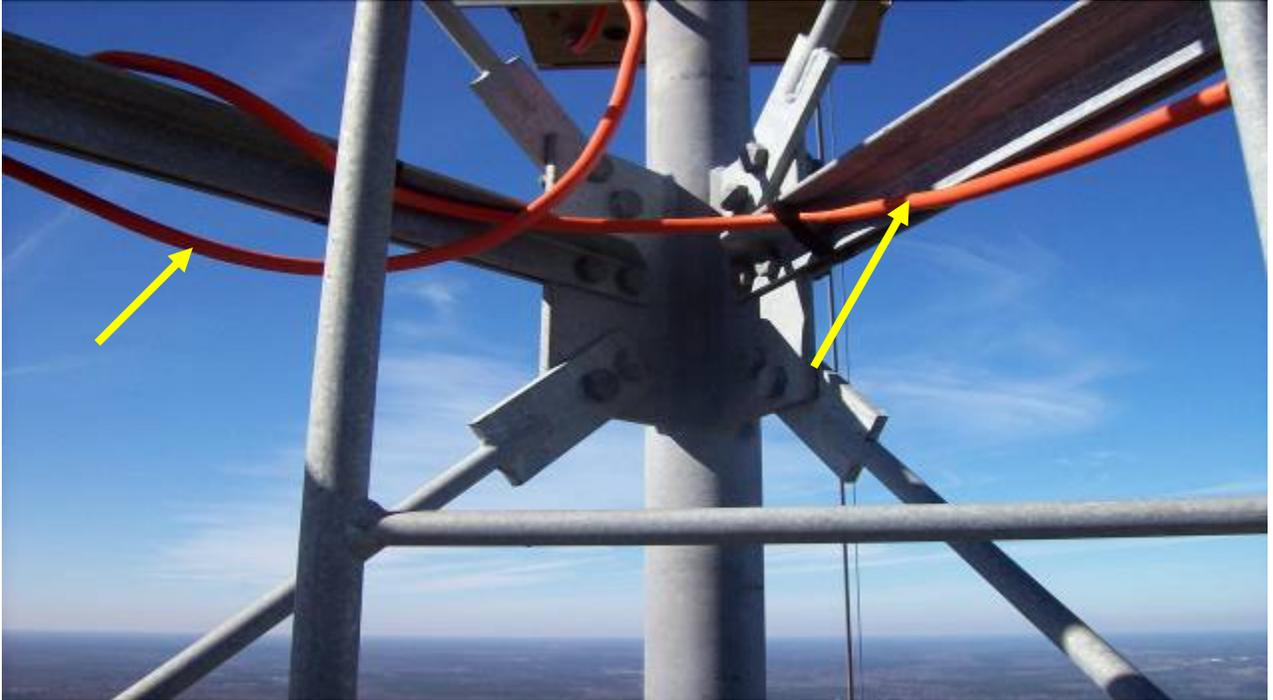
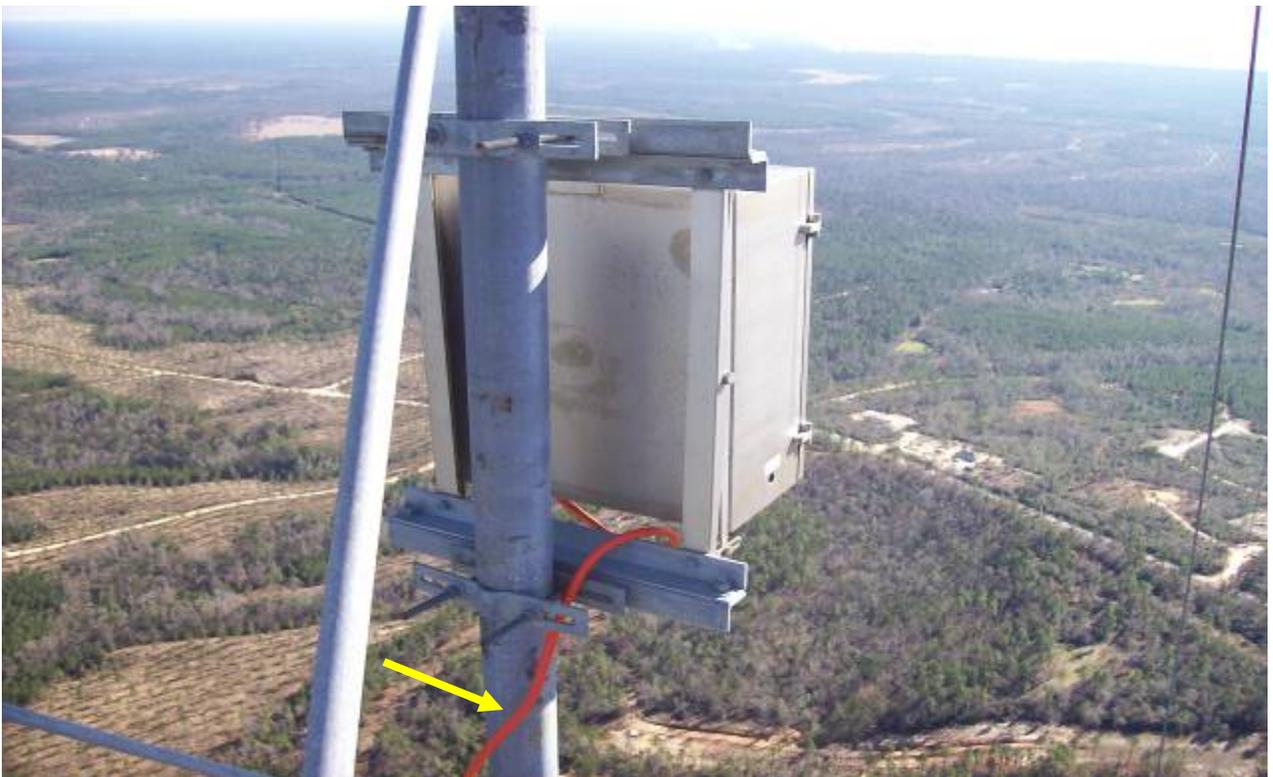
Photos show power supply cords for the strobe lights improperly secured to the tower.
